Lackawanna Cut-Off Restoration – Passenger Rail Study

DRAINAGE ANALYSIS

APPENDIX E.1 - EXISTING DRAINAGE STUDY

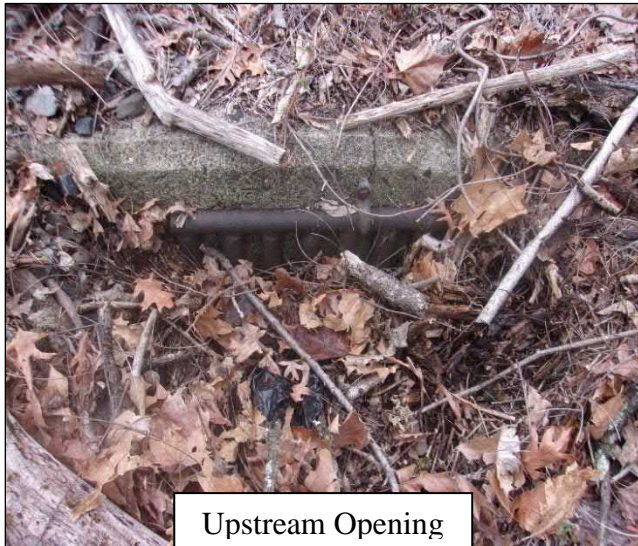
Upstream Opening

DRAINAGE OBSERVATION		
Condition	Inlet	Outlet
Overgrown		
Crushed		
Eroded		
Sedimentation		
Estimated % Blocked	95	
Deteriorated/Rusted		
Ponding/Incomplete Drainage		
Poor Channel Alignment		
Baseflow Present

Could Not Locate
 Downstream Opening

Drainage Recommendations:

- Remove sediment and debris from upstream opening and channel.
- Stabilize upstream channel with rock apron.
- Replace deteriorated upstream concrete headwall.

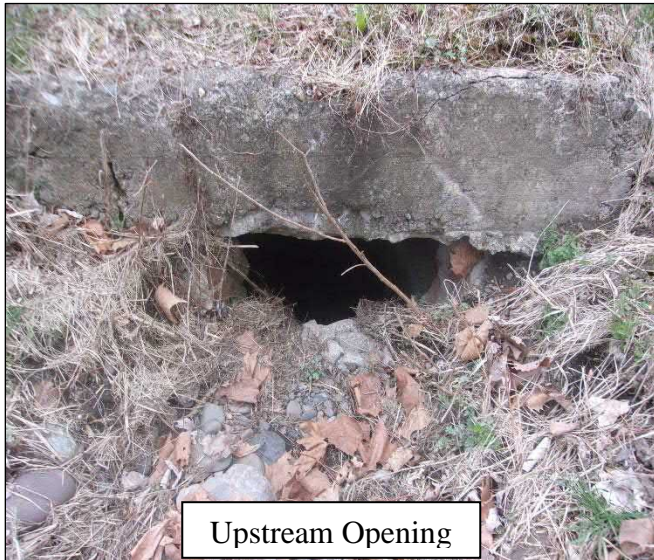
Upstream Opening

DRAINAGE OBSERVATION		
Condition	Inlet	Outlet
Overgrown		
Crushed		
Eroded		
Sedimentation		
Estimated % Blocked	50	
Deteriorated/Rusted		
Ponding/Incomplete Drainage		
Poor Channel Alignment		
Baseflow Present

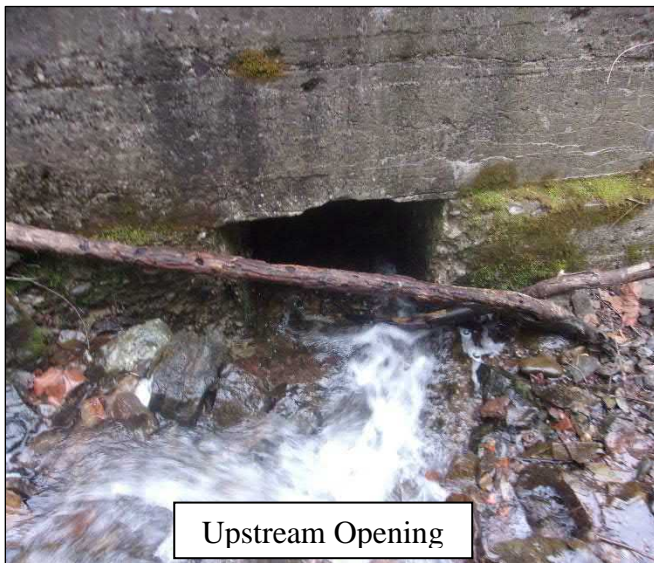
Upstream Opening

DRAINAGE OBSERVATION		
Condition	Inlet	Outlet
Overgrown		
Crushed		
Eroded		
Sedimentation		
Estimated % Blocked		
Deteriorated/Rusted		
Ponding/Incomplete Drainage		
Poor Channel Alignment	X	
Baseflow Present	X	X

Drainage Recommendations:

- Remove debris and excavate as needed to expose inlets.
- Grade a channel to ensure positive drainage from location of observed ponding to inlets.
- Stabilize entrance with a rock apron.

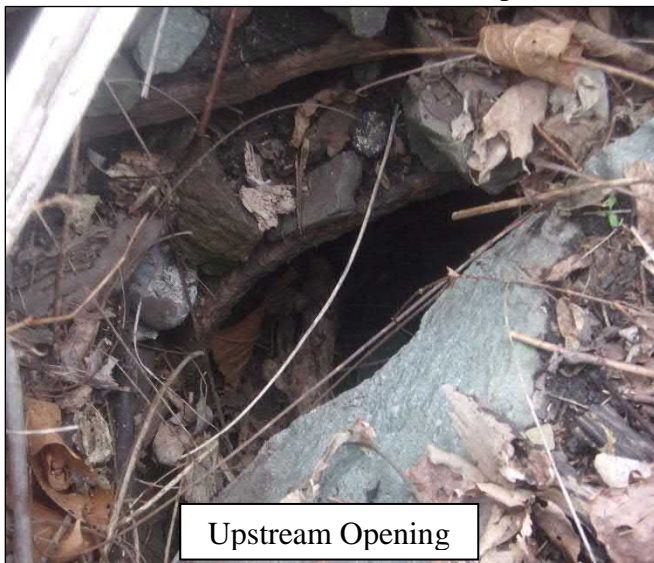
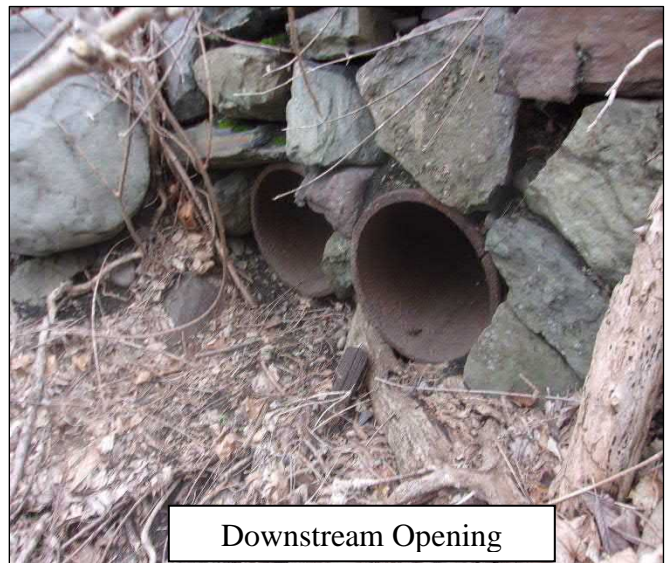
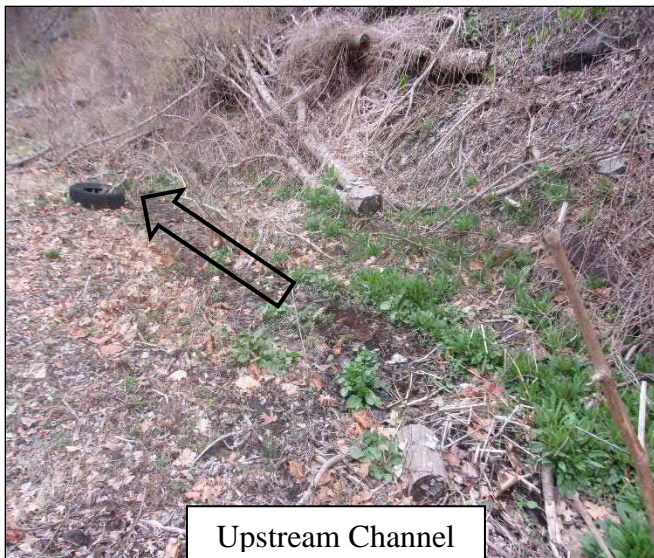
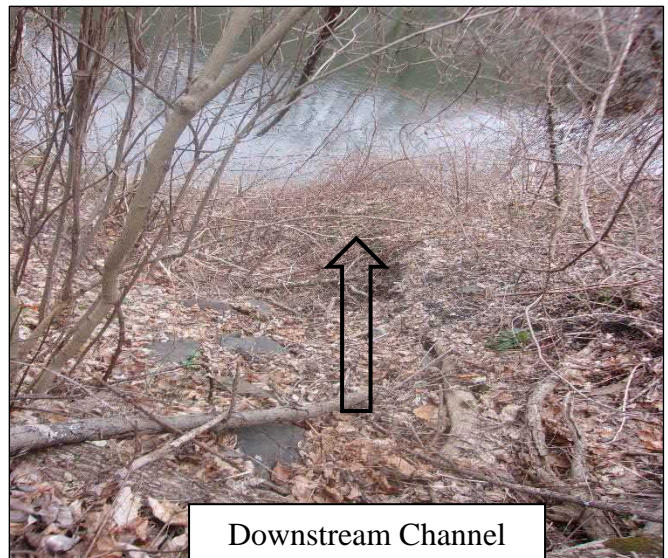
Pipe ID: Pipe 6
 Pipe Station: 60+50
 Pipe Size: 16"
 Pipe Material: Cast Iron
 Apron: Yes / No
 Drainage Area: 8.53 acres

DRAINAGE OBSERVATION		
Condition	Inlet	Outlet
Overgrown		
Crushed		
Eroded		
Sedimentation		
Estimated % Blocked	70	
Deteriorated/Rusted		
Ponding/Incomplete Drainage	X	
Poor Channel Alignment	X	
Baseflow Present

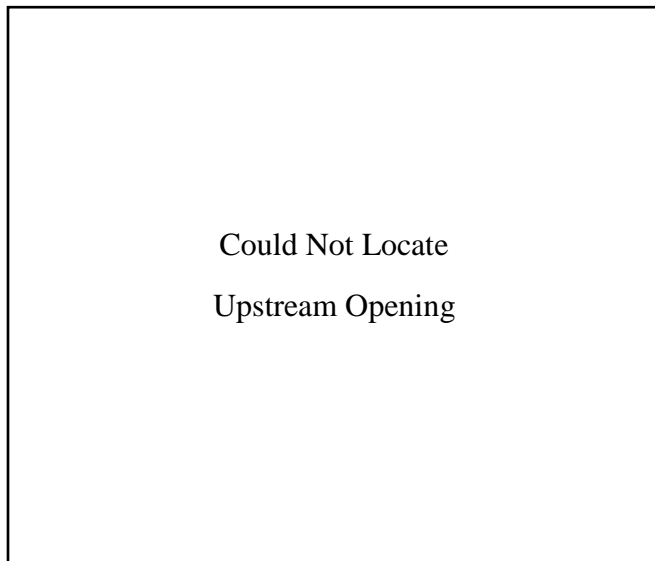
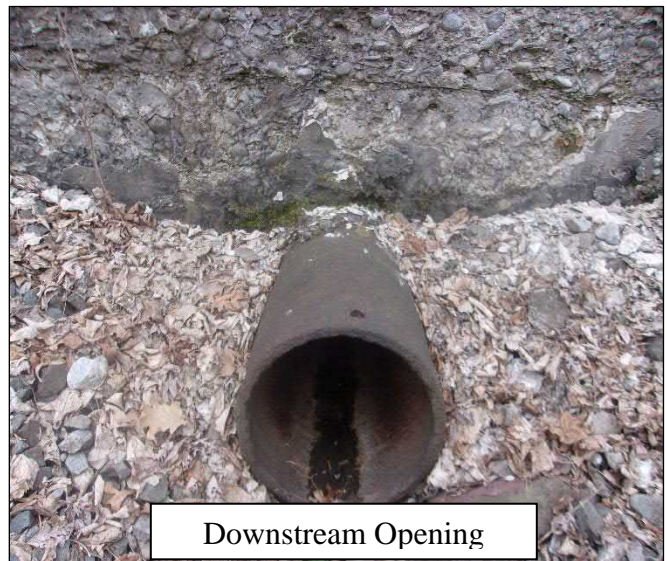
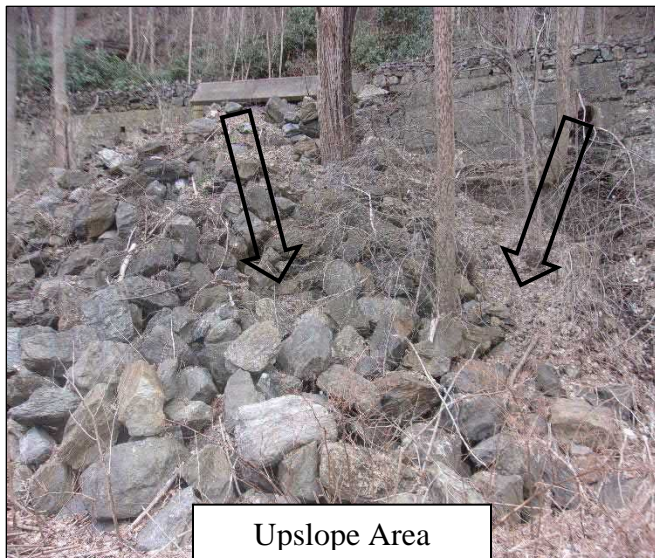
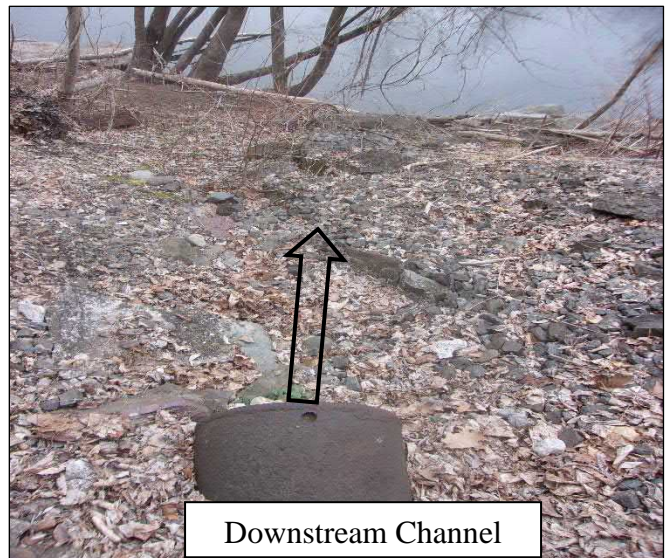
Pipe ID: Pipe 7
 Pipe Station: 66+80
 Pipe Size: 16"
 Pipe Material: Cast Iron
 Apron: Yes / No
 Drainage Area: 15.14 acres

DRAINAGE OBSERVATION		
Condition	Inlet	Outlet
Overgrown		
Crushed		
Eroded		
Sedimentation		
Estimated % Blocked		
Deteriorated/Rusted		
Ponding/Incomplete Drainage		
Poor Channel Alignment		
Baseflow Present

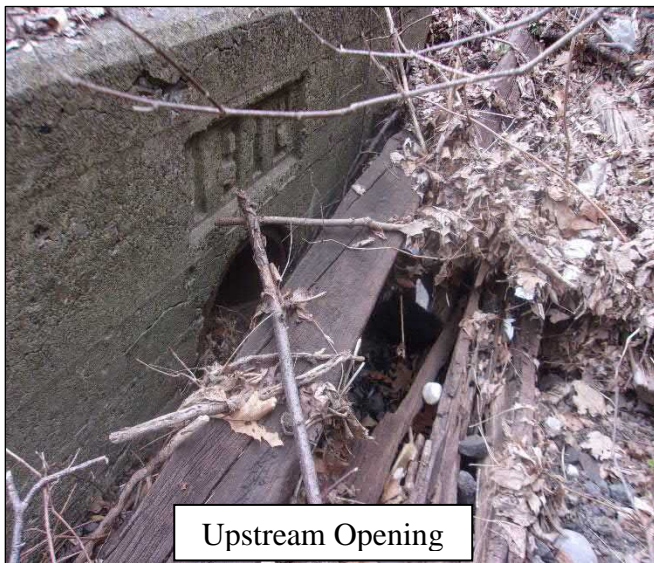
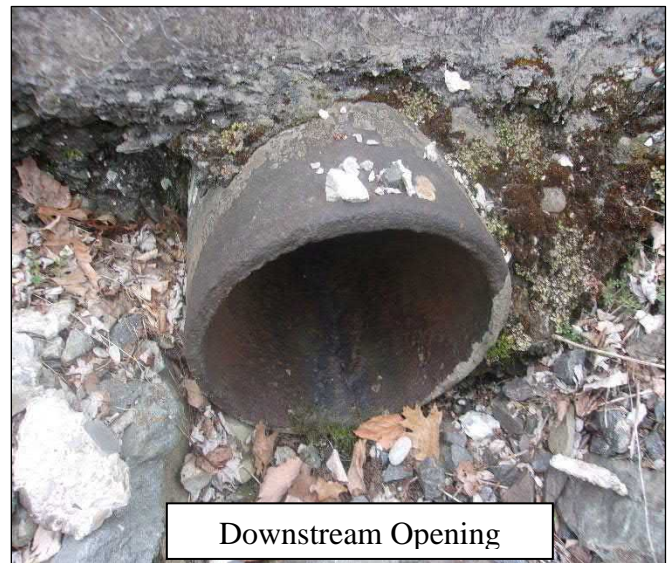
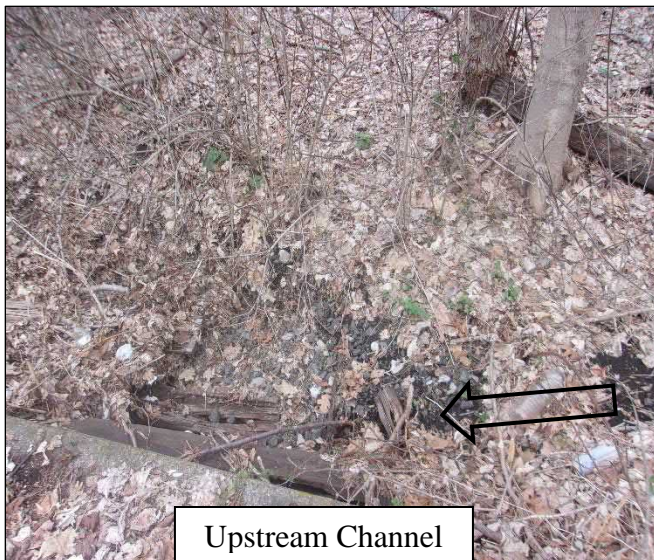
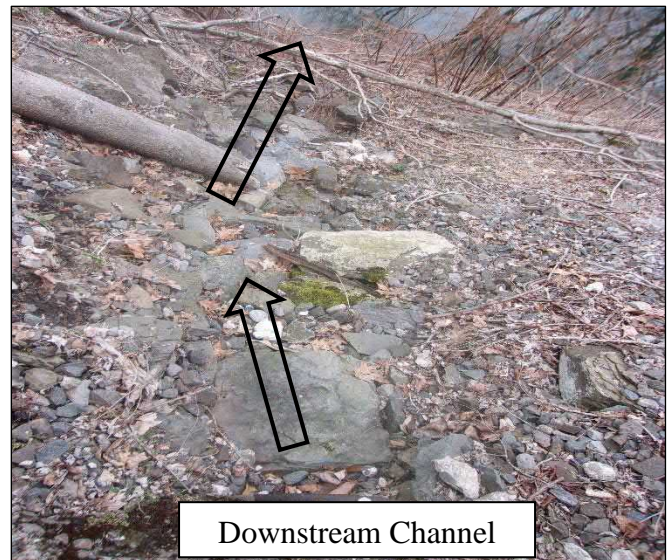
Pipe ID: Pipe 8
 Pipe Station: 68+20
 Pipe Size: 16"
 Pipe Material: Cast Iron
 Apron: Yes / No
 Drainage Area: 1.93 acres

DRAINAGE OBSERVATION		
Condition	Inlet	Outlet
Overgrown		
Crushed		
Eroded		
Sedimentation	X	
Estimated % Blocked	50	
Deteriorated/Rusted		
Ponding/Incomplete Drainage		
Poor Channel Alignment		
Baseflow Present

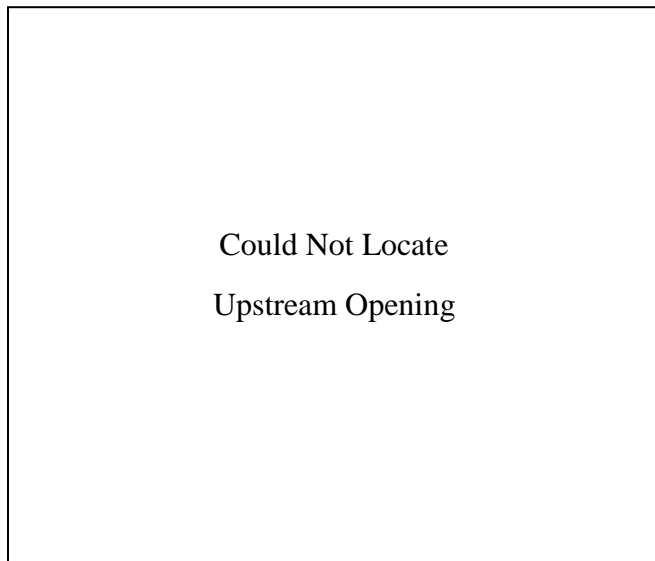
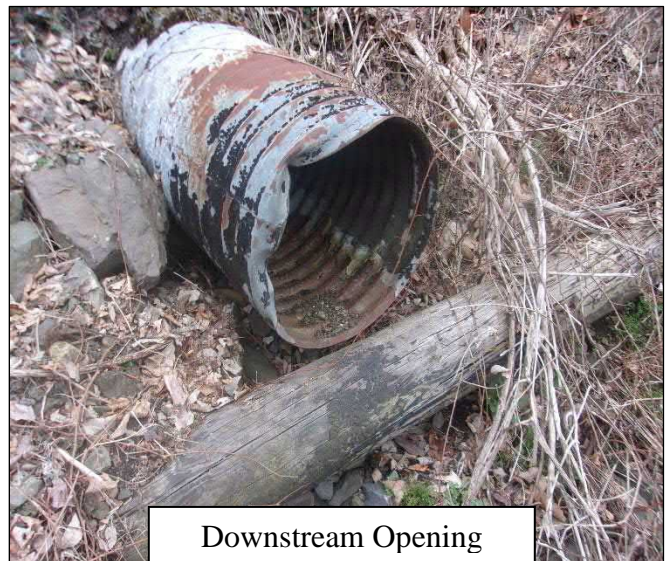
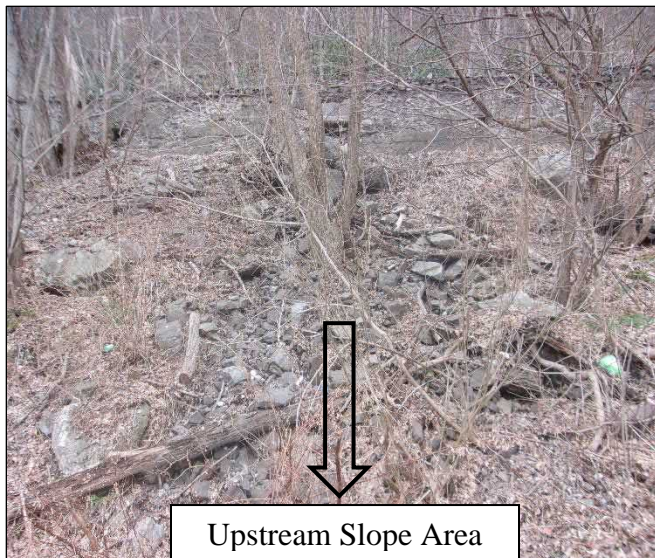
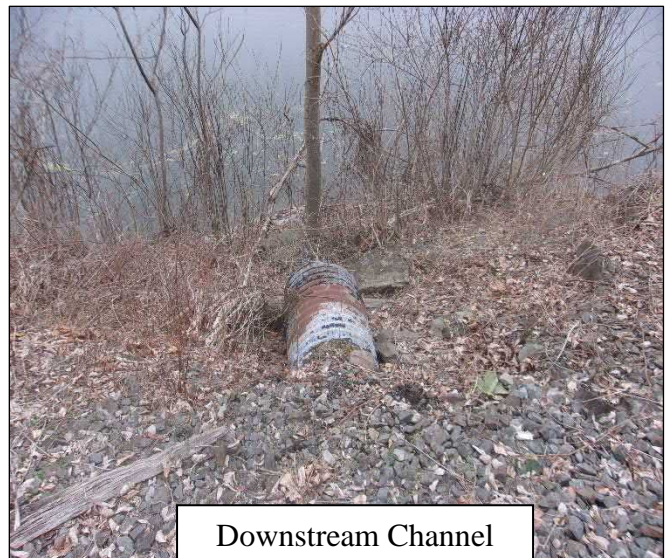
Pipe ID: Pipe 12
 Pipe Station: 94+90
 Pipe Size: 18"
 Pipe Material: Corrugated Metal
 Apron: Yes / No
 Drainage Area: 23.35 acres

DRAINAGE OBSERVATION		
Condition	Inlet	Outlet
Overgrown		
Crushed		X
Eroded		
Sedimentation		
Estimated % Blocked		
Deteriorated/Rusted		X
Ponding/Incomplete Drainage		
Poor Channel Alignment		
Baseflow Present

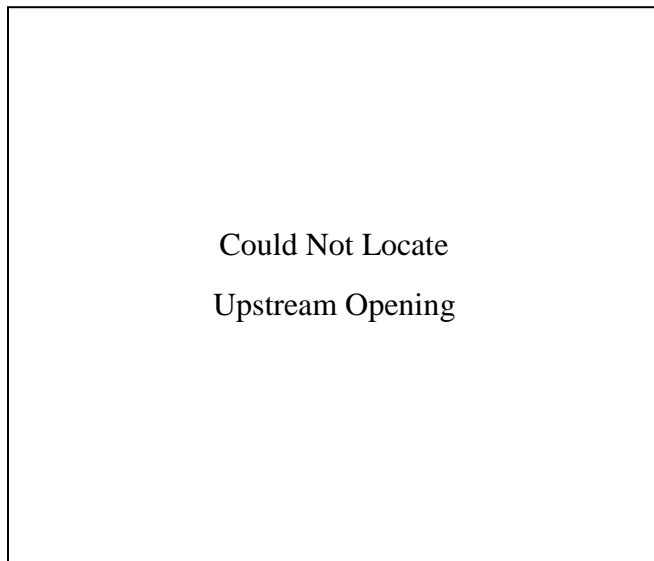
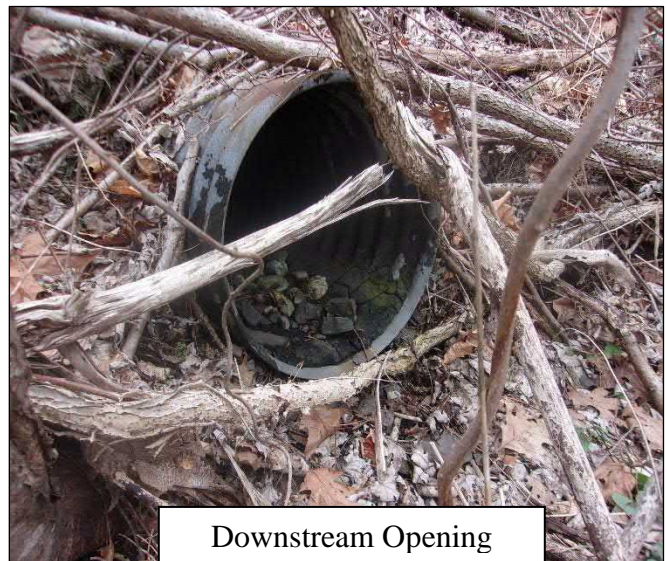
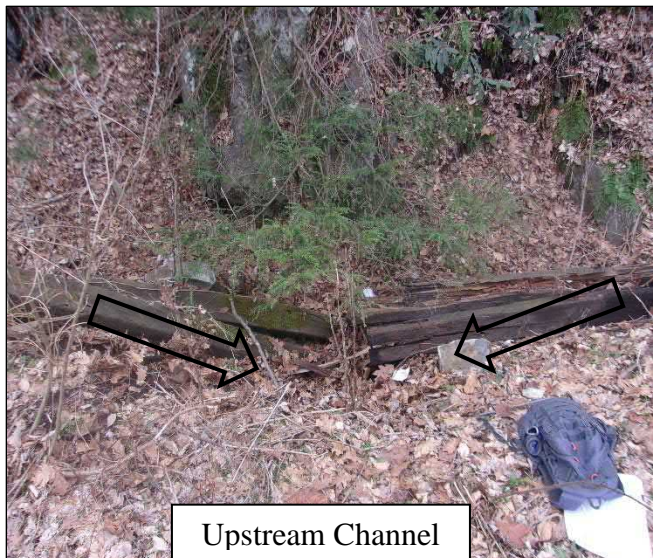
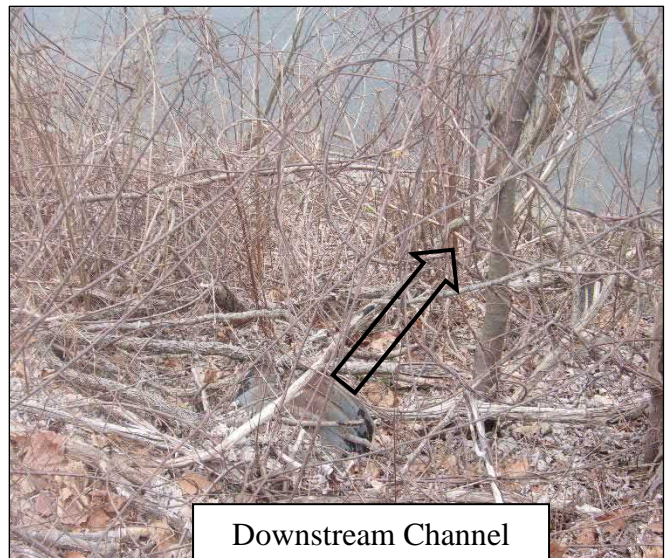
Pipe ID: Pipe 13
 Pipe Station: 104+15
 Pipe Size: 20"
 Pipe Material: Cast Iron
 Apron: Yes / No
 Drainage Area: 49.58 acres

DRAINAGE OBSERVATION		
Condition	Inlet	Outlet
Overgrown		X
Crushed		
Eroded		
Sedimentation		
Estimated % Blocked		
Deteriorated/Rusted		
Ponding/Incomplete Drainage		
Poor Channel Alignment		
Baseflow Present

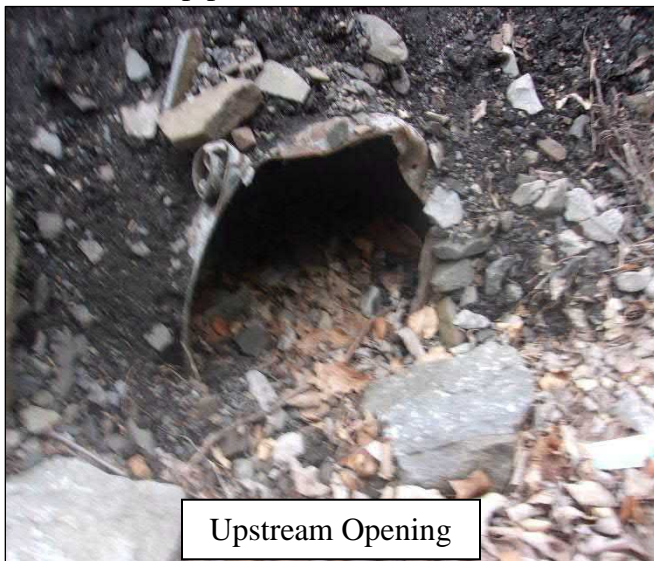
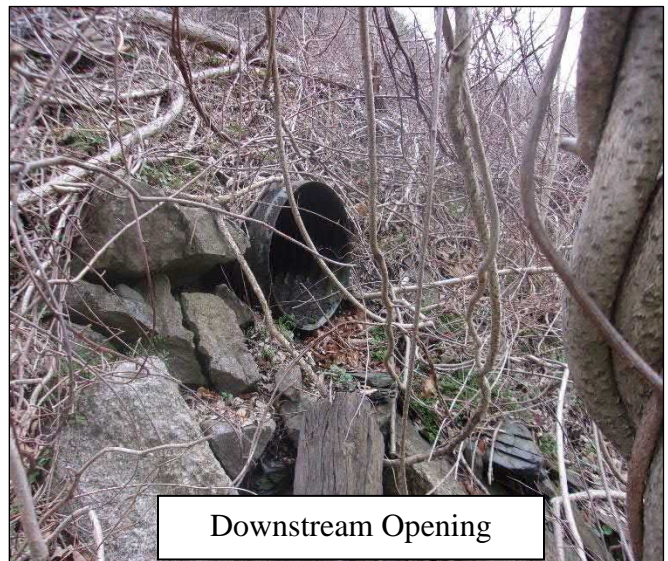
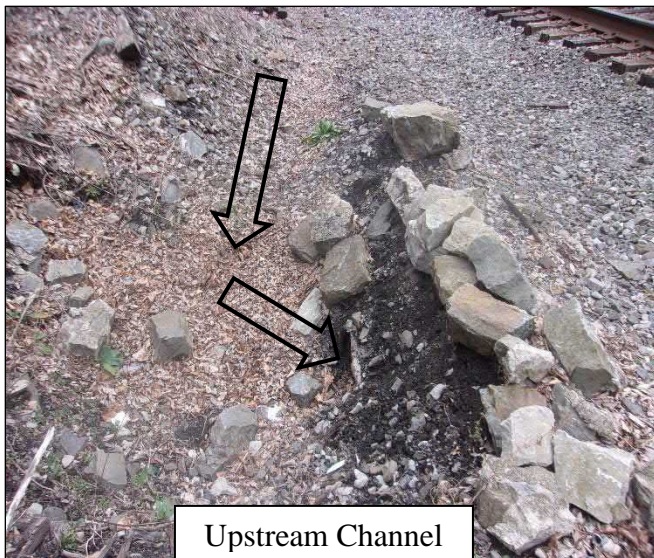
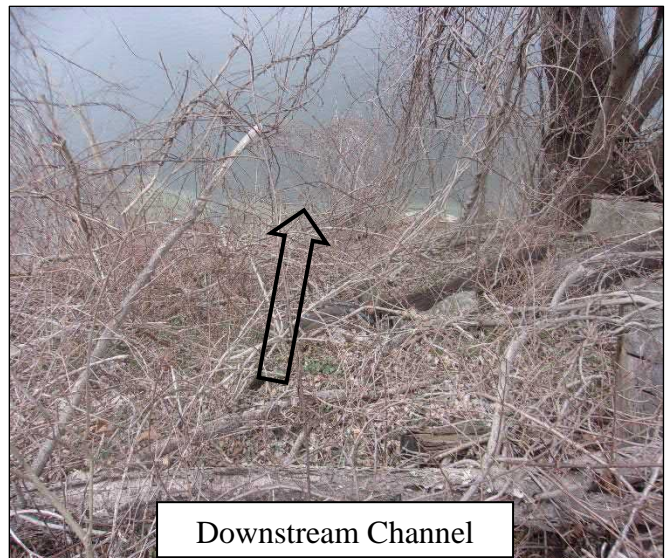
Pipe ID: Pipe 16
 Pipe Station: 129+00
 Pipe Size: 18"
 Pipe Material: Cast Iron
 Apron: Yes / No
 Drainage Area: 17.77 acres

DRAINAGE OBSERVATION		
Condition	Inlet	Outlet
Overgrown		X
Crushed		
Eroded		
Sedimentation	X	
Estimated % Blocked	20	
Deteriorated/Rusted	X	
Ponding/Incomplete Drainage		
Poor Channel Alignment		
Baseflow Present

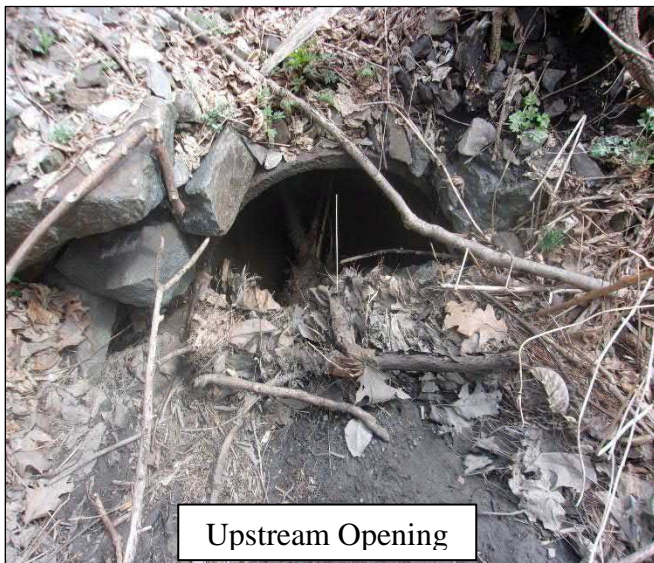
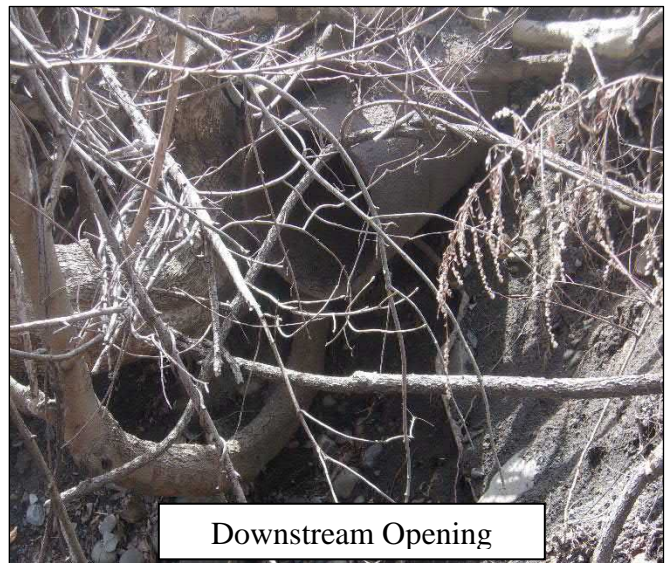
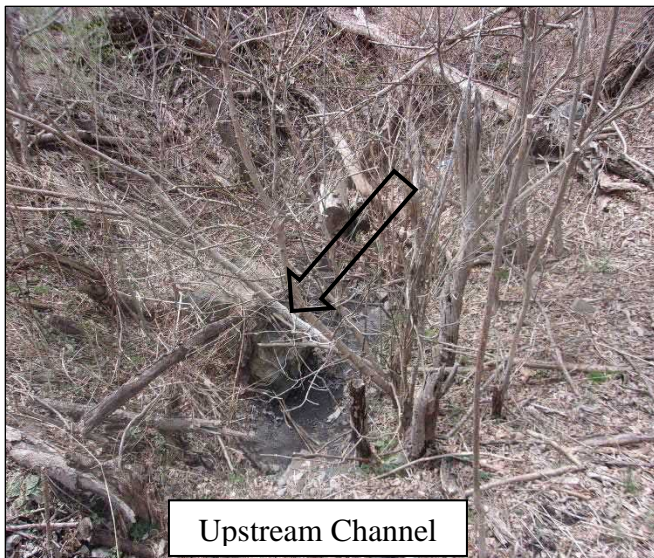
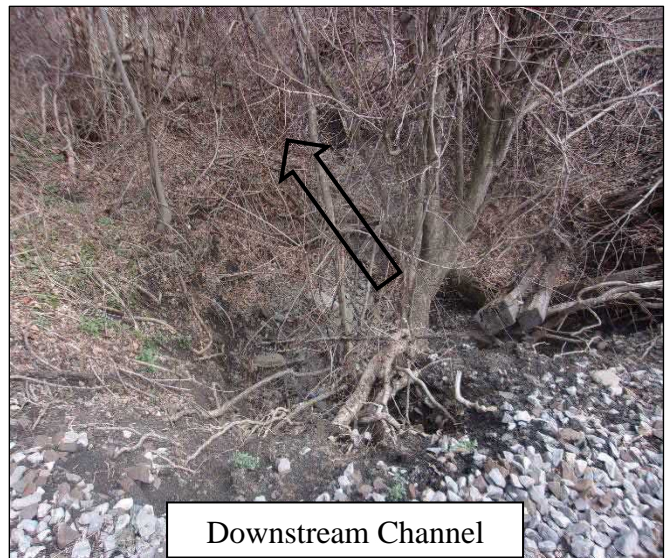
Pipe ID: Pipe 17
 Pipe Station: 139+00
 Pipe Size: 24"
 Pipe Material: Clay
 Apron: Yes / No
 Drainage Area: 31.95 acres

DRAINAGE OBSERVATION		
Condition	Inlet	Outlet
Overgrown		X
Crushed		
Eroded		
Sedimentation	X	
Estimated % Blocked	50	
Deteriorated/Rusted		
Ponding/Incomplete Drainage		
Poor Channel Alignment		
Baseflow Present

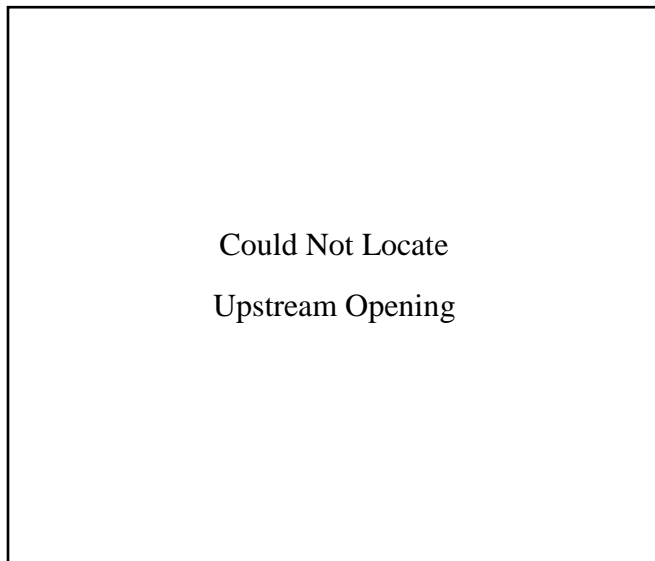
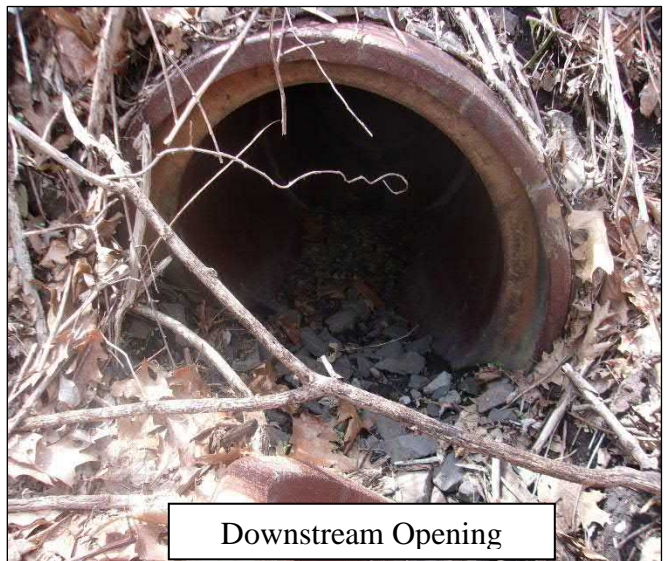
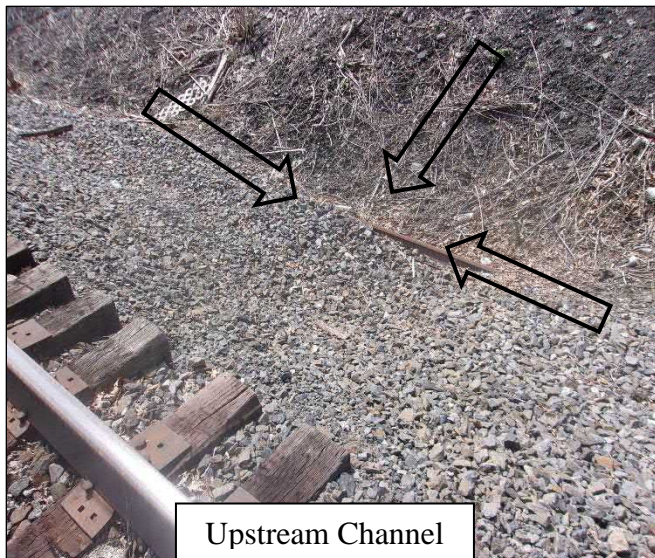
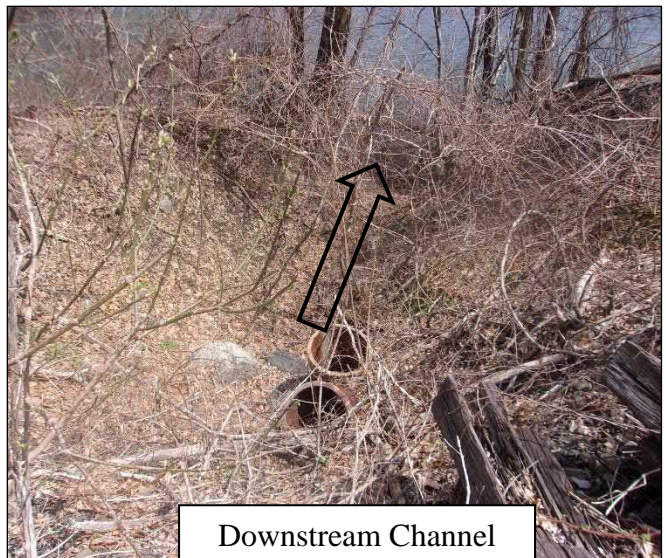
Pipe ID: Pipe 18
 Pipe Station: 169+10
 Pipe Size: 12"
 Pipe Material: Cast Iron
 Apron: Yes / No
 Drainage Area: 76.58 acres

(see the Drainage Catalog in [APPENDIX E.3](#)). Pipe 18 (Station 169+10 on the Drainage Baseline) is a good example of common conditions affecting pipes between Water Gap Station and Slateford Junction. The topography suggests that the pipe should convey drainage from about 77 acres of the watershed, but the upstream end of the pipe could not be located in the field and is assumed to be buried or overgrown and blocked by grass and weeds.

DRAINAGE OBSERVATION		
Condition	Inlet	Outlet
Overgrown		X
Crushed		
Eroded		
Sedimentation		X
Estimated % Blocked		
Deteriorated/Rusted		
Ponding/Incomplete Drainage		
Poor Channel Alignment		
Baseflow Present

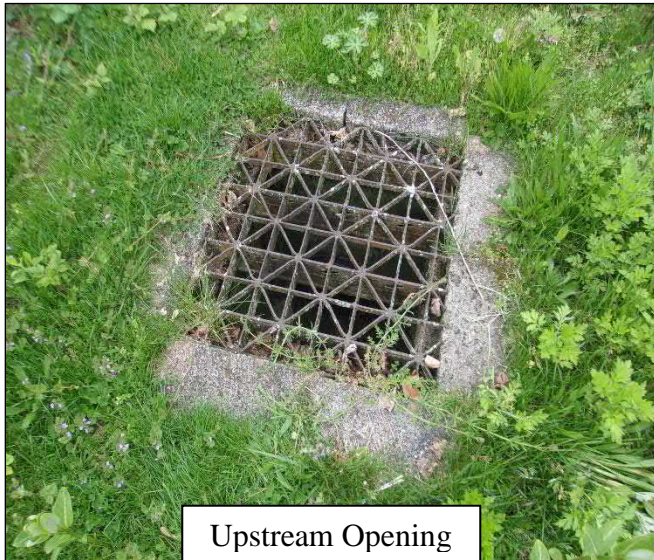
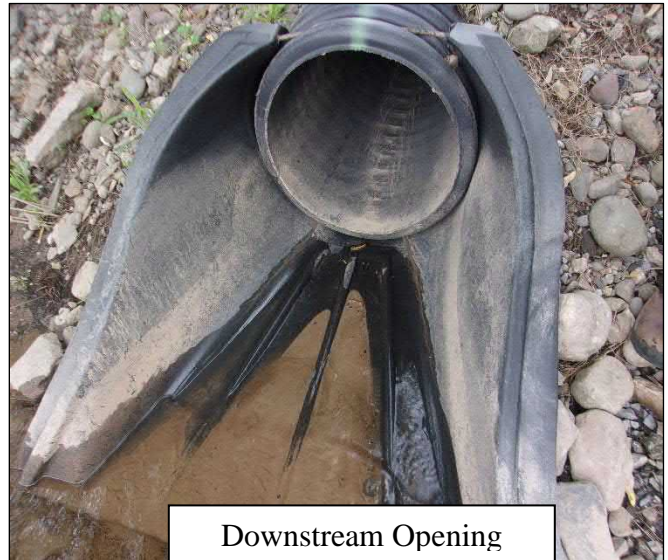
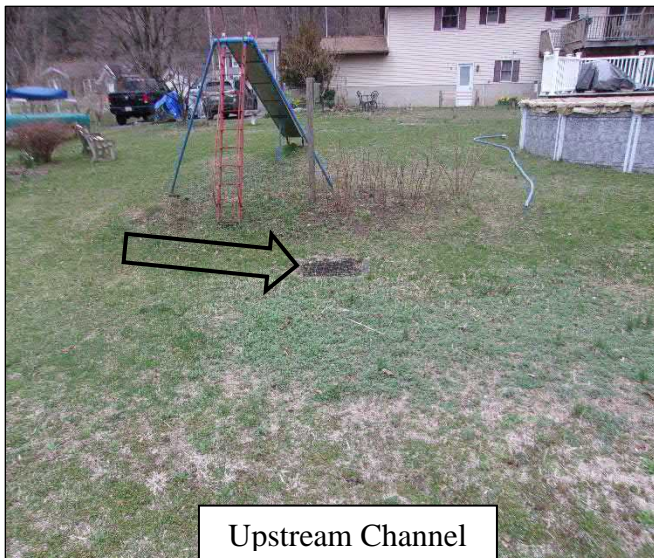
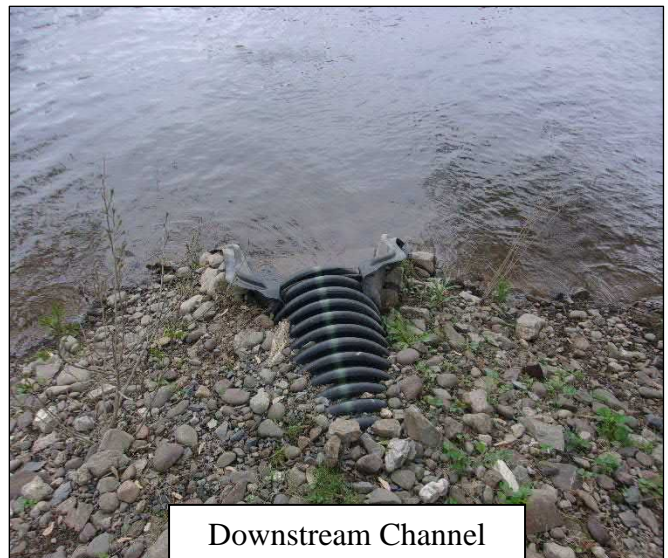
Pipe ID: Box 4
 Pipe Station: 235+75
 Pipe Size: 34" x 42" (span x rise)
 Pipe Material: Stone Masonry
 Apron: Yes / No
 Drainage Area: 273.14 acres

DRAINAGE OBSERVATION		
Condition	Inlet	Outlet
Overgrown		
Eroded		
Sedimentation		
Estimated % Blocked		
Deteriorated/Rusted		
Ponding/Incomplete Drainage		
Poor Channel Alignment		
Baseflow Present

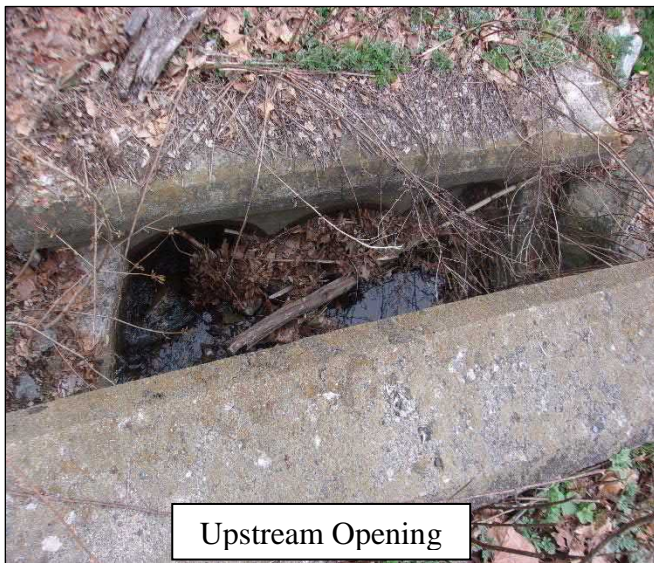
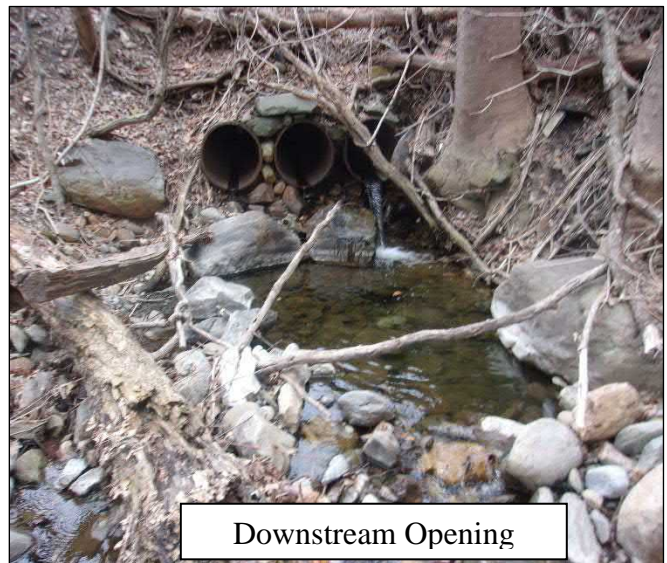
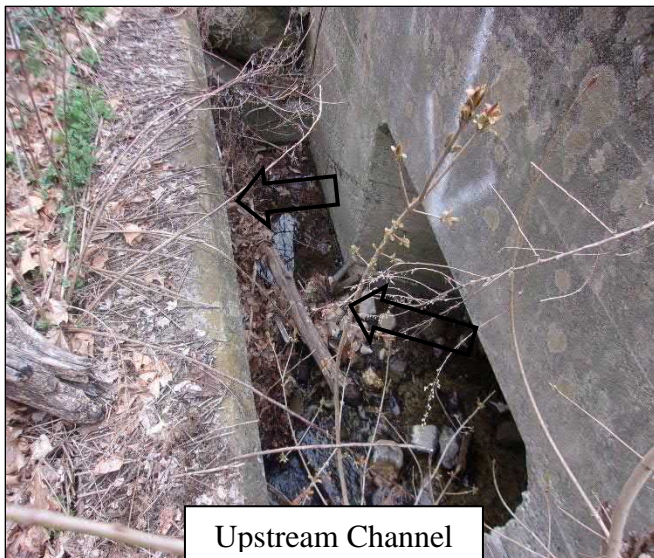
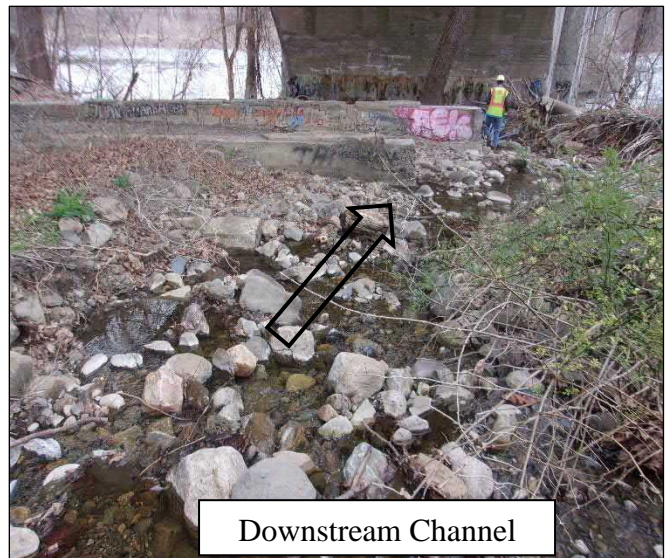
ID: Pipe 25
 Station: 239+50 (Abandoned Line)
 Size: 48"
 Material: Plastic
 Apron: Yes / No
 Drainage Area: 14.87 acres

DRAINAGE OBSERVATION		
Condition	Inlet	Outlet
Overgrown		
Crushed		
Eroded		
Sedimentation		
Estimated % Blocked	50	
Deteriorated/Rusted		
Ponding/Incomplete Drainage		X
Poor Channel Alignment	X	
Baseflow Present	X	X

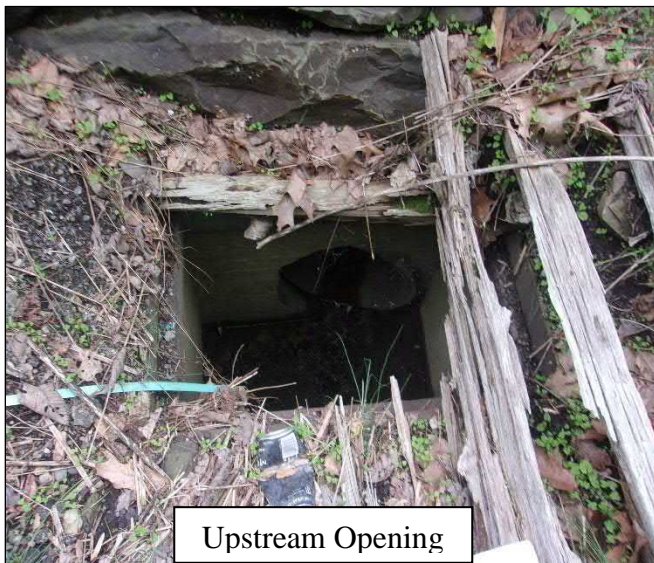
Upstream Opening

DRAINAGE OBSERVATION		
Condition	Inlet	Outlet
Overgrown		
Crushed		
Eroded		
Sedimentation		
Estimated % Blocked		
Deteriorated/Rusted		
Ponding/Incomplete Drainage		
Poor Channel Alignment		
Baseflow Present

Drainage Recommendations:

- Replace headwall with a manhole or provide bulkhead across upstream opening to direct all flow into pipe and avoid seepage.
