## **Lackawanna Cut-Off Restoration – Passenger Rail Study**

### **UNDERWATER INSPECTION REPORT**

**Underwater Inspection of  
Delaware River Viaduct over Delaware River  
October 10, 2019  
For  
Pennsylvania Northeast Regional Rail Authority  
(PNRRA) and The Lackawanna County Planning  
Commission**

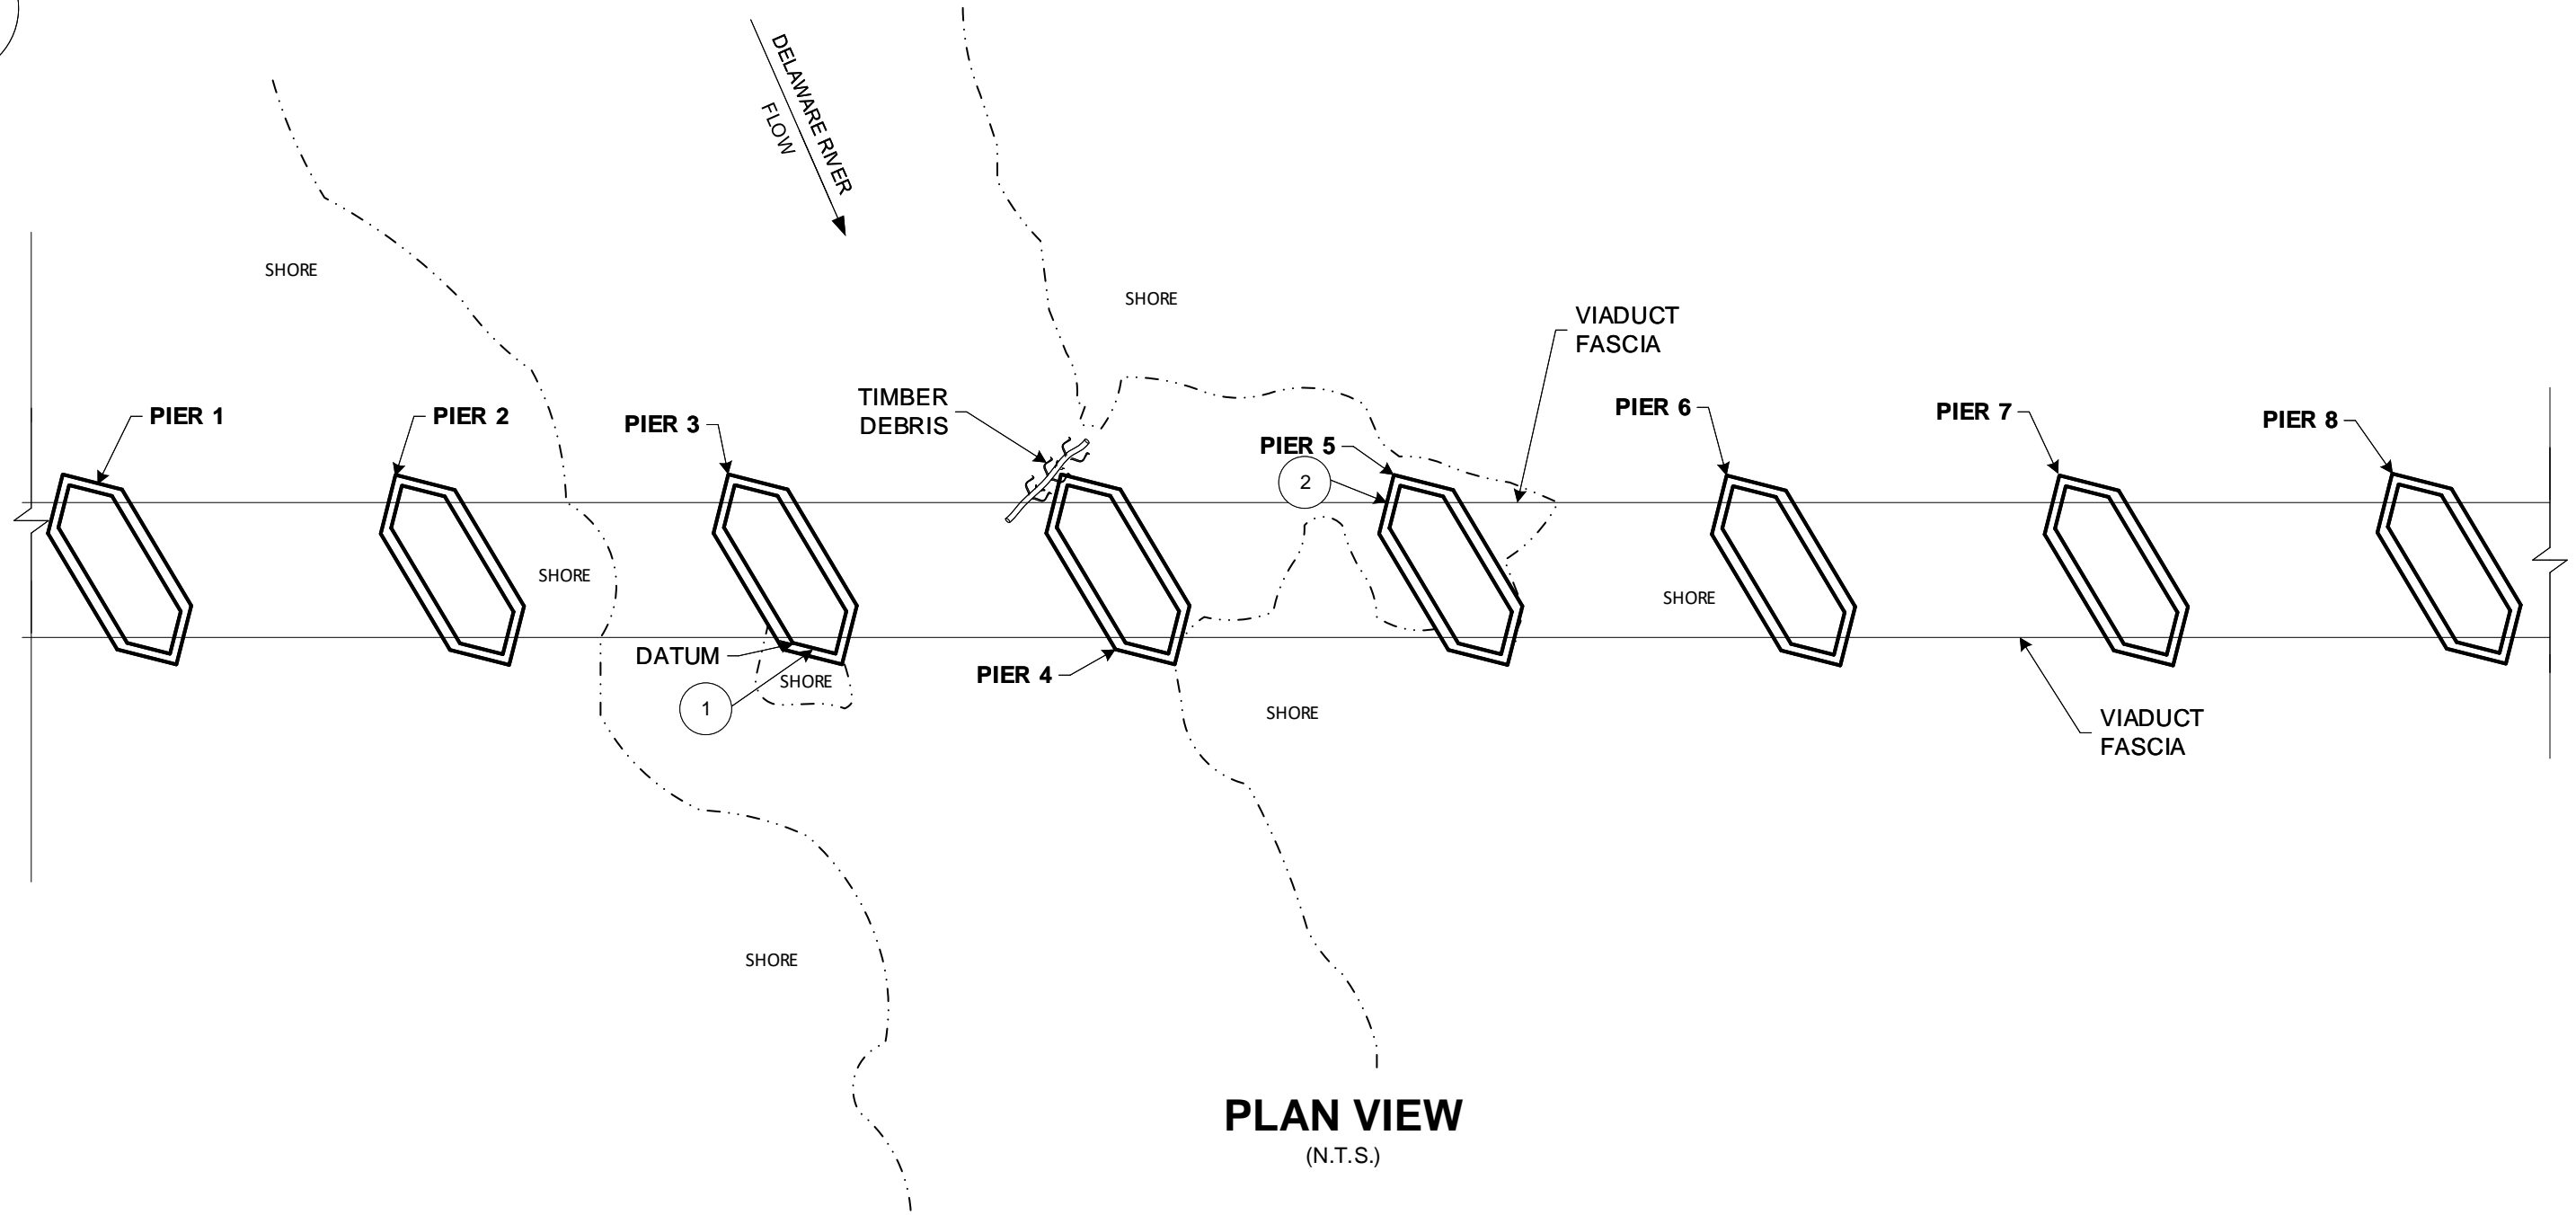
<b>GPI</b> Greenman-Pedersen, Inc. Engineering and Construction Services	<b>PLAN VIEW</b>
	DELAWARE RIVER VIADUCT OVER DELAWARE RIVER LACKAWANNA COUNTY

1. Structural crack up to 2" W x 12' H. Crack continues through end of pier causing the entire section to be delaminated from pier.
2. Spall that extended 7' long, 1' high with a 1' penetration into the footing.

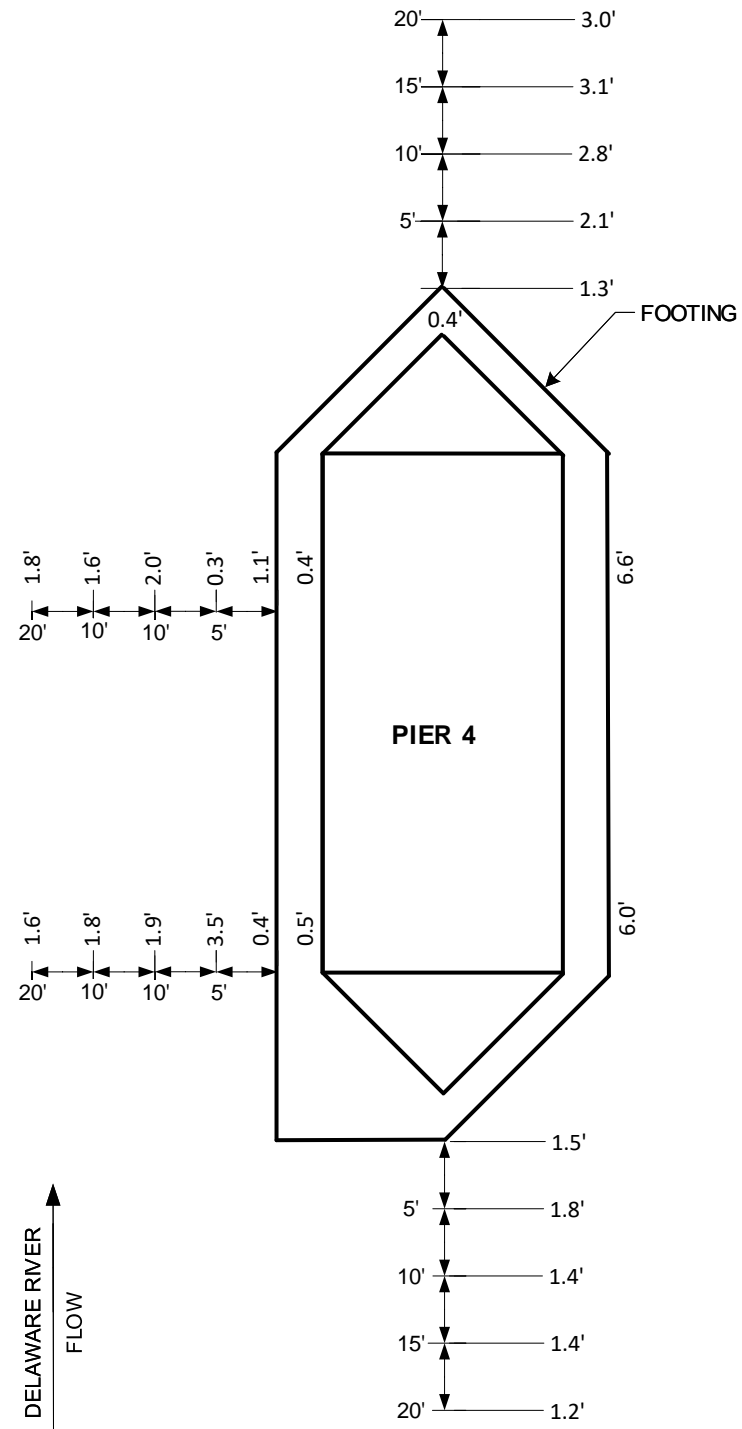
**PIER 4 SOUNDINGS**  
(N.T.S.)

**CURRENT  
TOO STRONG  
TO OBTAIN  
SOUNDINGS**

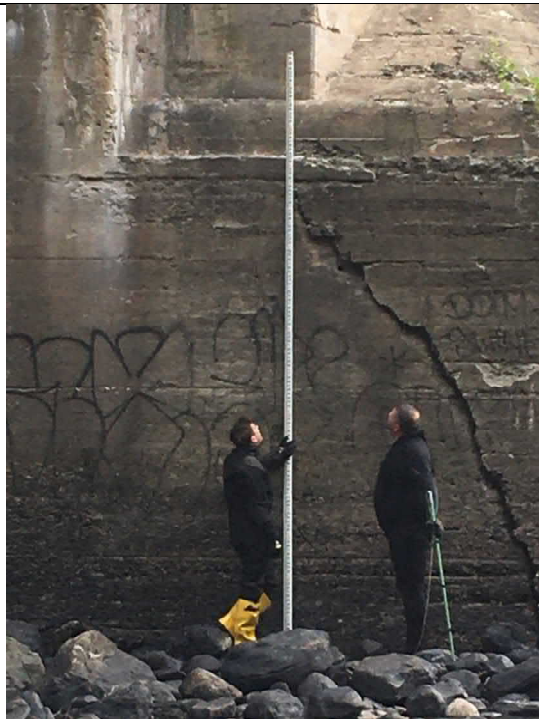
Photograph 10

Date of Inspection:	October 10, 2019
Water Temperature:	65 Degrees F
Waterway Velocity (Current):	5 ft./sec. flow from north to south at time of inspection.
Depth Turbidity (Visibility):	Approximately 10 feet
Channel Bottom Material:	River rock / cobbles and gravel over bedrock
Scour Countermeasures:	N/A
Extent of Marine Growth:	Light algae growth.
Substructures Inspected:	Piers 3 (west), 4 (center) and 5 (east).
Water Elevation Datum:	Measured to top of downstream ledge of Pier 3 (see photo 10).
Water Surface Elevation:	Approximately 13.6' feet below datum location to WSE.

View of Datum (13.6') location on Pier 3 West Elevation

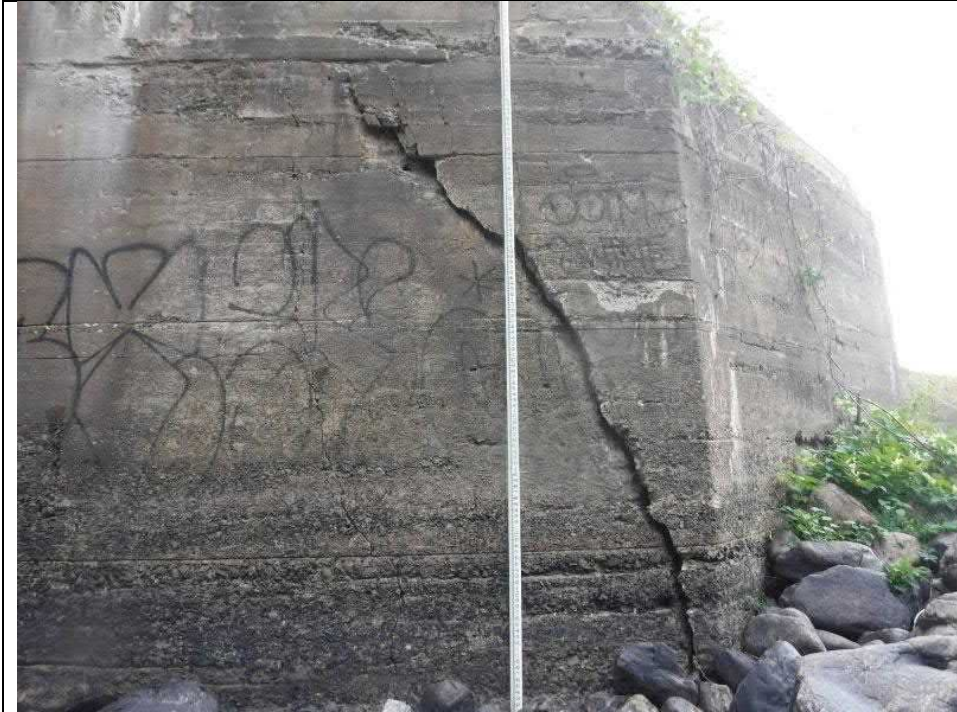
Photograph 11  
Structural Crack Pier 3  
West elevation. 2" wide  
full penetration to back  
side of pier wall  
downstream

- Significant crack in concrete larger than 2" in width (Photograph 11) near the downstream west face that continued and surfaced on the back downstream pier nose. Hammer sounding indicated that entire section of concrete to be delaminated from the rest of the pier.
- On the west face near the upstream nose on the footing top there was a steel grate embedded in the top of the footing 18" wide by 20' long. (Photograph 23)
- On the west face near the middle of the pier there were several vertical cracks less than ¼" wide and deemed nonstructural.

The concrete pier walls had areas of small cracks that should be repaired to prevent entrance of water that could freeze and spall the concrete. Some of the cracks are horizontal and appear to be construction joints. There was a wide crack on the downstream end of Pier 3 that should be repaired as a large section of concrete has delaminated. It is unclear if the load carrying capacity of the pier has been reduced due to this crack and should be investigated through structural analysis. The mortar between masonry blocks should be repaired with vegetation removed.

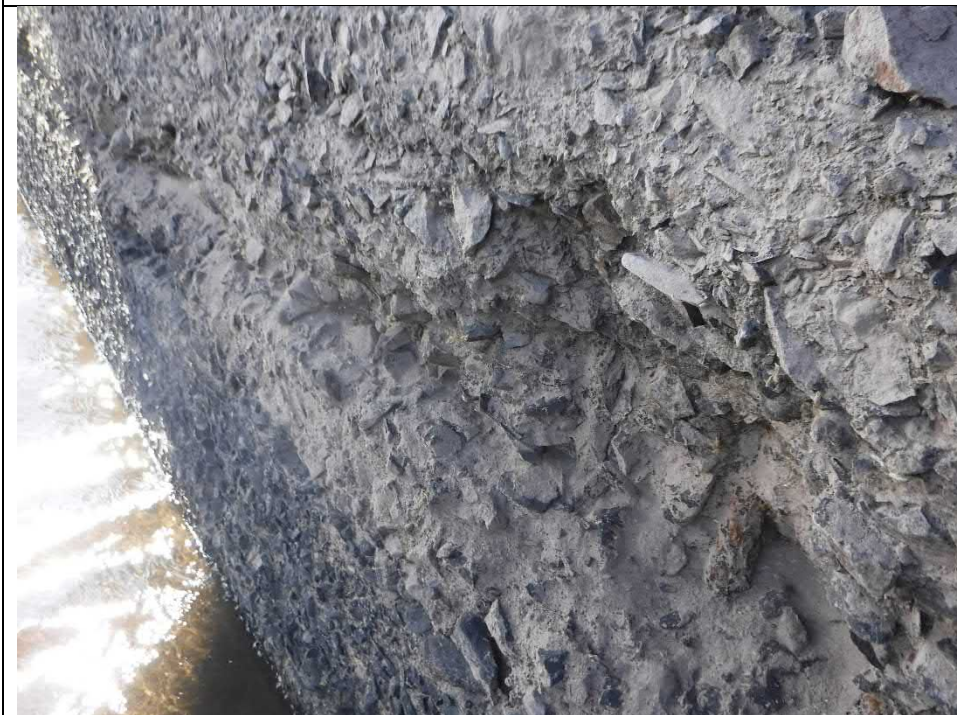
- The piers all have scaling due to abrasion from water and ice flow from the water line up about 10'. Concrete aggregate is exposed typically with ½" to 1" loss of mortar up to 2" penetration (Photograph 12). There was slightly less scaling underwater than above. (Photograph 17) All piers had exposed vertical faces of the supporting footing from 6" up to almost 7'. There was no undermining found, very little spalling and other defects. The concrete appeared to be in generally good condition for the age of the structure. The armoring of the upstream noses with stone masonry exhibited loss of mortar in between the stone layers. (Photograph 22)

Photograph 12  
View of Pier 4, scaling up  
to 2" penetration above  
water. Typical of all piers.

The portions of the substructure inspected underwater appear to be in fair condition with no undermining or major deterioration. Water flow has abraded the concrete causing scaling and exposed concrete aggregate which does not affect structural capacity.

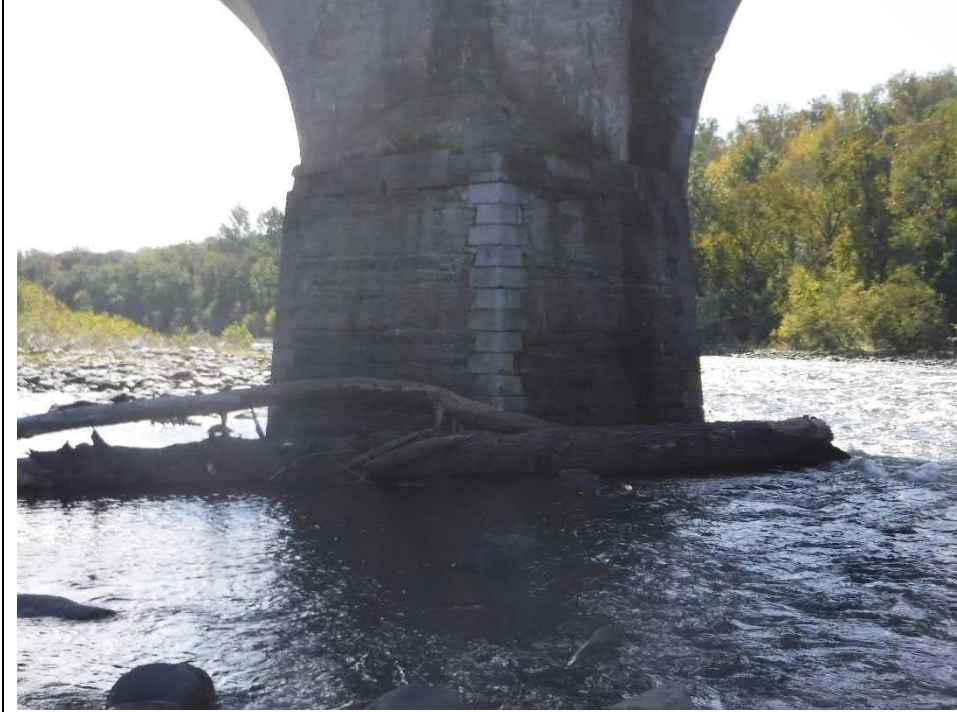
- Pier had the most vertical exposure of the footing at close to 7' but there was no undermining found.
- The concrete appeared to be in good condition.
- There was a large log and miscellaneous debris on the upstream nose. This debris can cause constricted flow and lead to local scour around the pier and should be removed when able. (Photograph 13)

Photograph 13  
View of Pier 4 Upstream  
nose with timber debris

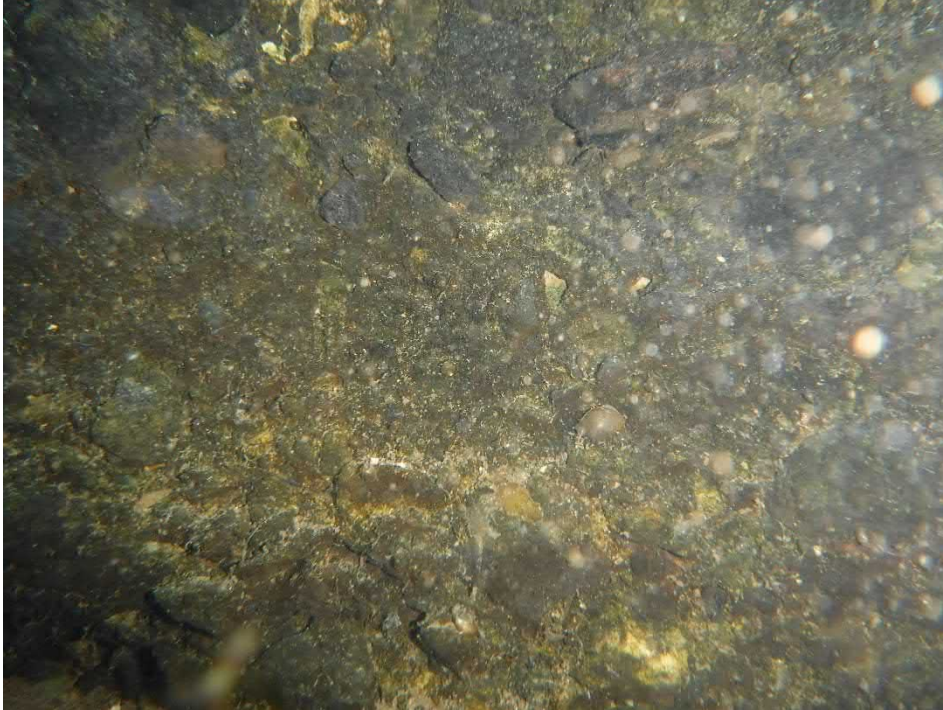
Photograph 17

View of Pier 4, scaling up to 1" penetration underwater. Typical of all piers.

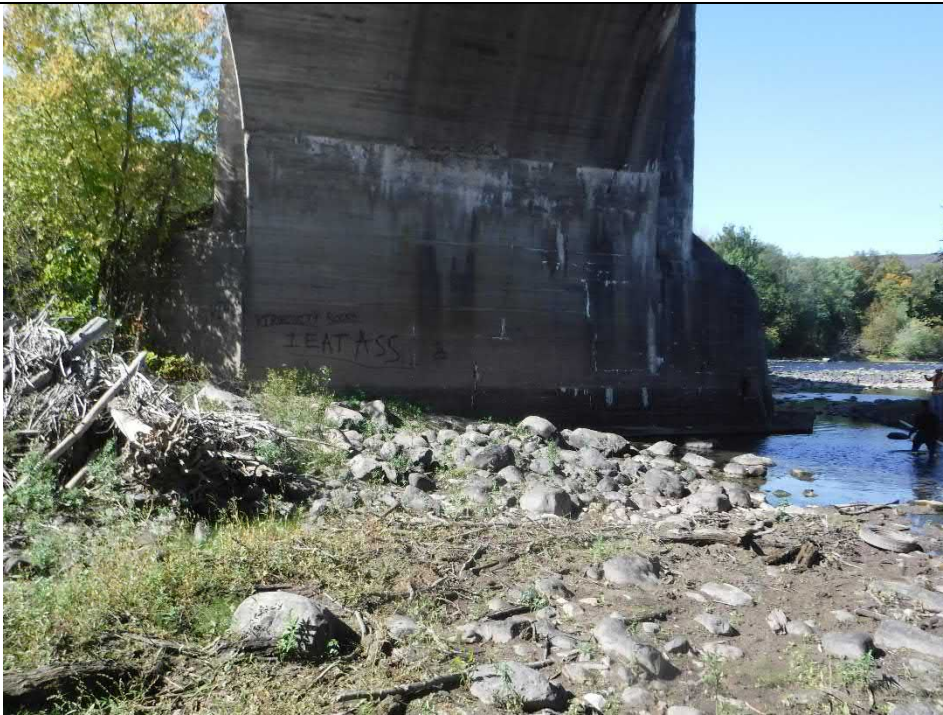
- Pier exhibited concrete deterioration a bit more extensive than the other two piers, most likely since the pier and footing had less water surrounding it and thereby exposed to weather.
- The west side of the front nose footing on the vertical face had a spall that extended 7' long, 1' high with a 1' penetration into the footing.
- Around the pier there was evidence of aggregation which means soil has been deposited during periods of high-water flow and is causing areas of high elevation (small islands) which can constrict water flow and potentially increase the chances of scour. (Photograph 20)

Photograph 20  
View of of Pier 5 East  
Elevation.

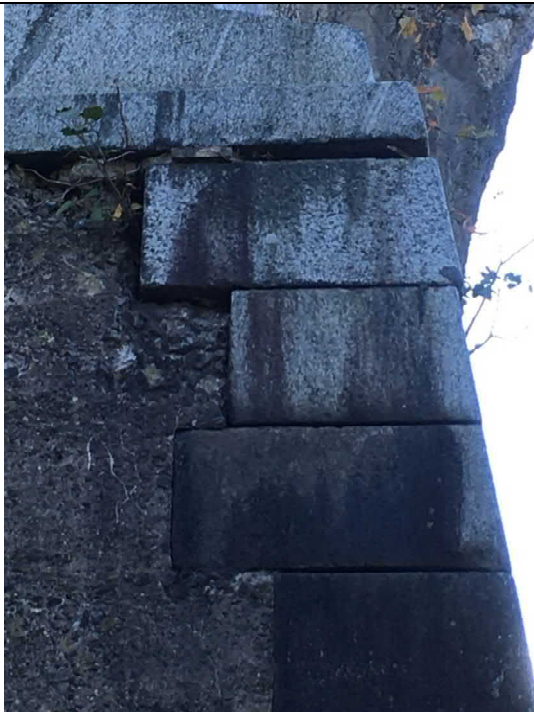
Photograph 22

View of typical pointing  
missing from Masonry  
blocks

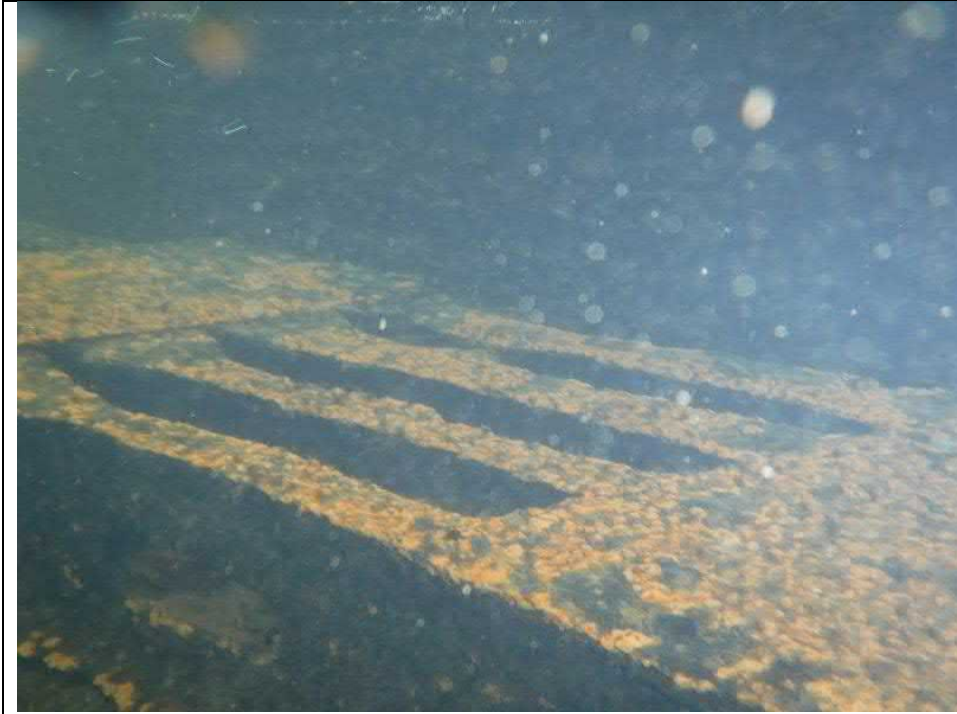
Photograph 23

View of steel grate  
embedded in top of  
footer of Pier 3 West  
face.
