Lackawanna Cut-Off Restoration – Commuter Rail Study

December 2019 – Final Report

Greenman-Pedersen, Inc.
52 Glenmaura National Blvd., Suite 302
Scranton, PA 18505

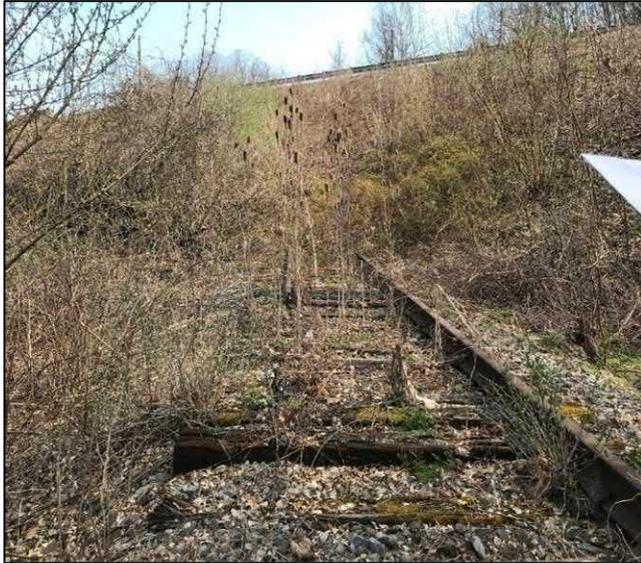
Figure 8 - Looking South at Filled-in Slateford Bridge and track remnants

There were no records of the original structure found and therefore little is known about the original structure type or if any portions of it were removed prior to being filled in. Existing fill in the area of the Slateford Road bridge will require excavation to allow construction of a new structure. Although little is known about the remnants of the existing bridge, a cost for removal of the existing bridge structure has been included in the cost estimate for the Slateford Road bridge as a conservative approach.

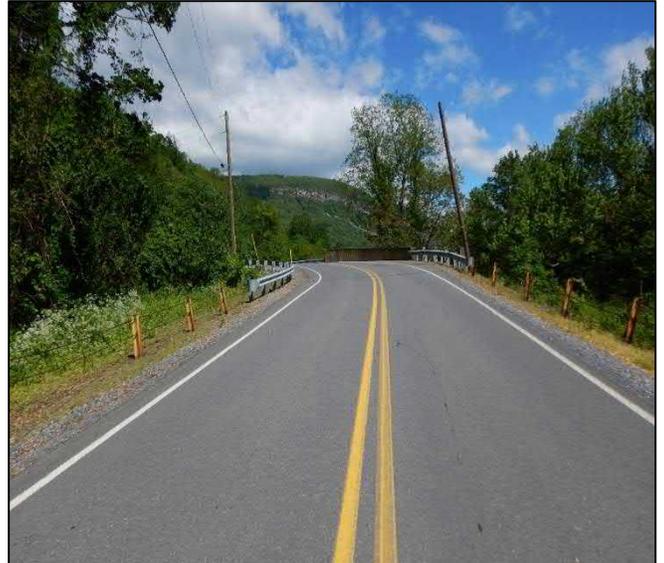
Figure 9 - Looking North along Slateford Road towards Filled-in Slateford Bridge
