Road Safety Review Field Report

Lackawanna-Luzerne Transportation Study (LLTS) MPO

Field Visits: September 23rd & October 11th, 2022

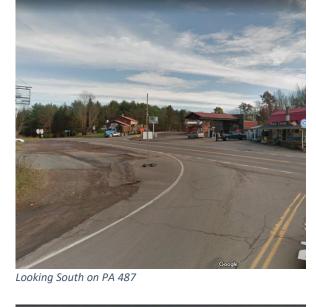
Overhead map view

Field Observations: Vehicles are travelling at a high rate of speed due to the minimal cross streets in this rural setting. Drivers travelling west on PA 118 are navigating a bend in the road and have little time to stop for traffic at the intersections. Drivers also tend to underestimate the turn onto PA 487 and make turns at a high rate of speed, leading to collisions. The parking lot of a nearby convenience store and ice cream shop is also being used by drivers to cut across PA 118 to access the other roadways.

- 1. Curbing the parking lots of adjacent businesses for access control.
- 2. Sight distance improvements.
- 3. High friction surface treatment.
- 4. Advisory roadway paint to warn drivers to slow for the intersection.
- 5. Signage improvements.
- 6. Dedicated right hand turn onto PA 487.
- 7. PA 118 corridor study.

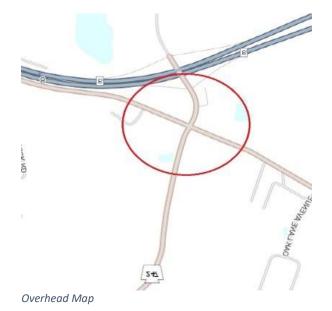
PA 348 Looking West

Field Observations: There is very limited space for pedestrians and there is a sign listed on PA 247 marking it as a bike route while there is only a very small shoulder.

- 1. Add bike path accommodations.
- 2. Put in sidewalks to allow safe travel for pedestrians.
- 3. Add sharrows.
- 4. Widen shoulders.
- 5. Add right hand turn lanes at intersection.

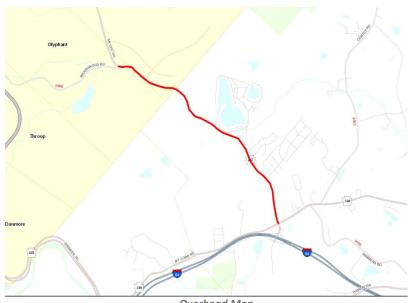
SR 247 Looking East

Field Observations: There were areas in the segment where drivers were speeding. The entire segment is in a mostly wooded area which can have effects on sight distance.

- 1. Add a guard rail with reflectors.
- 2. High friction surface treatment.
- 3. Widen shoulder.
- 4. Add rumble strips to shoulder.

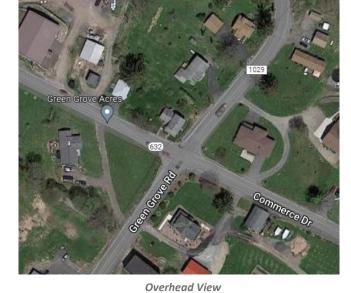
PA 632 Looking South

Field Observations: There is limited visibility of traffic traveling south on SR 1029. Even when stopped at one of the three signs, it is difficult to judge when to proceed through the intersection. There is a home with a retaining wall that creates significant sight distance issues at the intersection.

- 1. Make the intersection a 4-way stop.
- 2. Re-route SR 1029 as the connection of PA 247 to PA 632.
- 3. Sight distance improvements.
- 4. Reduce speed limit uphill on SR 1029.

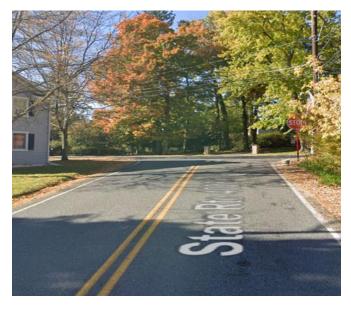
SR 4028 Looking North

Field Observations: There are sight distance issues when approaching PA 407 from SR 2048. During peak hours, the traffic buildup does not allow for proper flow of traffic coming from SR 4028. Traffic buildup at the intersection during peak hours can cause aggressive driving.

- 1. Improve sight distance by removing vegetation at intersection.
- 2. Make the intersection a three-way stop to avoid severe traffic buildup on PA 4028.
- 3. Make the intersection into a roundabout.
