Lackawanna Cut-Off Restoration – Passenger Rail Study

DRAINAGE ANALYSIS

APPENDIX E.1 - EXISTING DRAINAGE STUDY

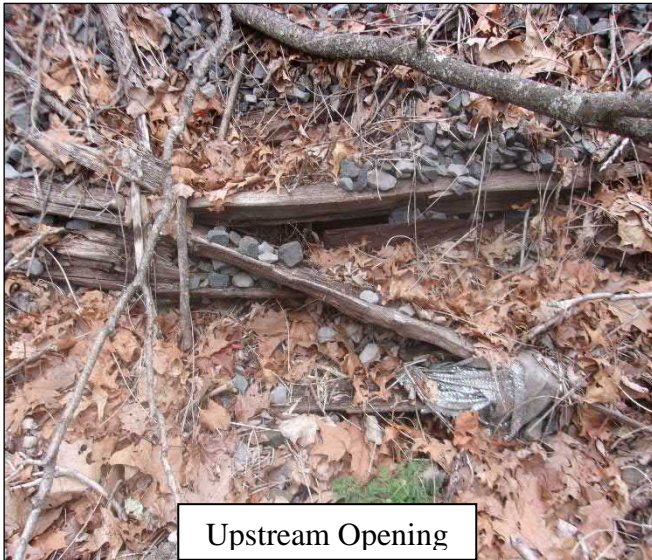
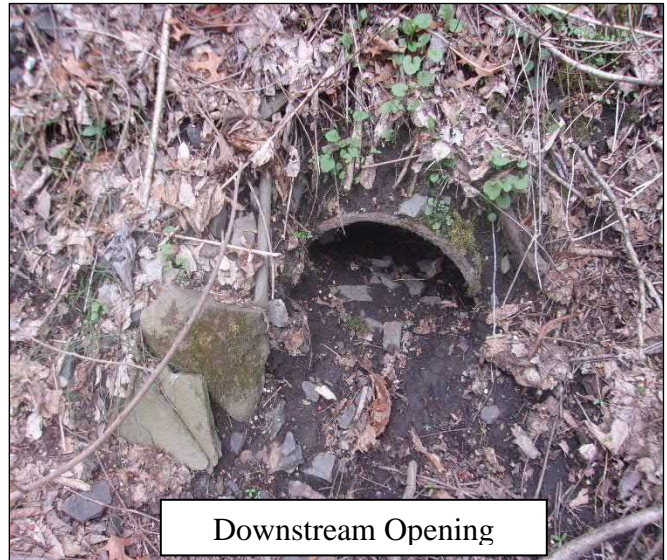
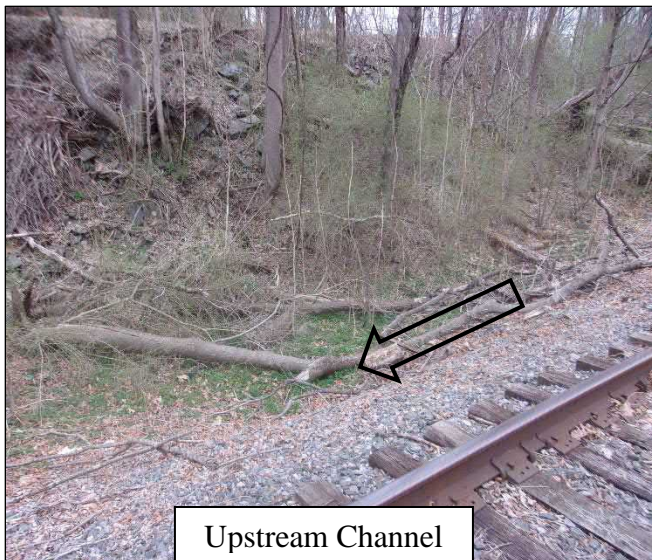
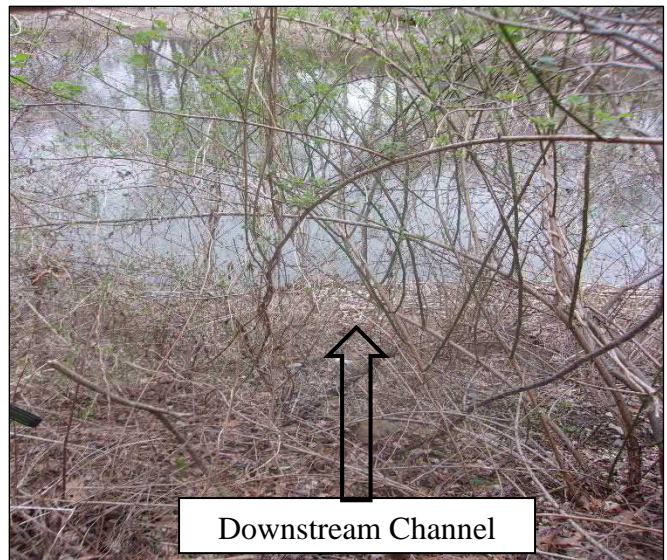
Pipe ID: Pipe 2
 Pipe Station: 33+25
 Pipe Size: Unknown
 Pipe Material: Unknown
 Apron: Yes / No
 Drainage Area: 1.20 acres

DRAINAGE OBSERVATION		
Condition	Inlet	Outlet
Overgrown		
Crushed		
Eroded		
Sedimentation		X
Estimated % Blocked	90	60
Deteriorated/Rusted		
Ponding/Incomplete Drainage		
Poor Channel Alignment		
Baseflow Present

Drainage Recommendations:

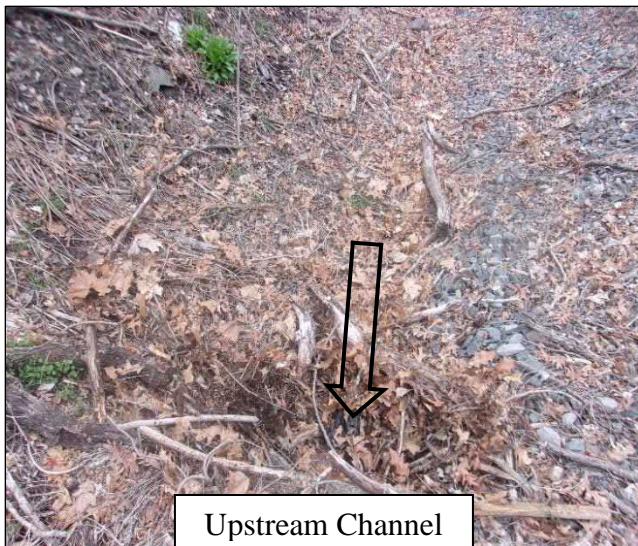
Upstream Channel

DRAINAGE OBSERVATION		
Condition	Inlet	Outlet
Overgrown		
Crushed		
Eroded		
Sedimentation		
Estimated % Blocked	95	
Deteriorated/Rusted		
Ponding/Incomplete Drainage		
Poor Channel Alignment		
Baseflow Present

Drainage Recommendations:

- Remove sediment and debris from upstream opening and channel.
- Stabilize upstream channel with rock apron.
- Replace deteriorated upstream concrete headwall.

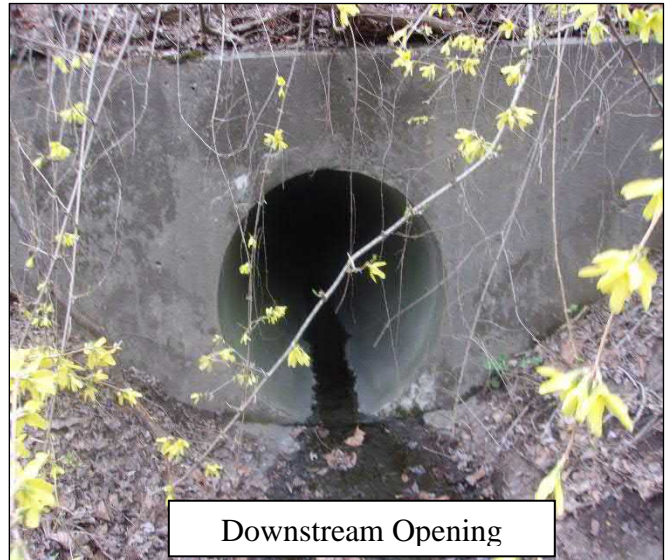
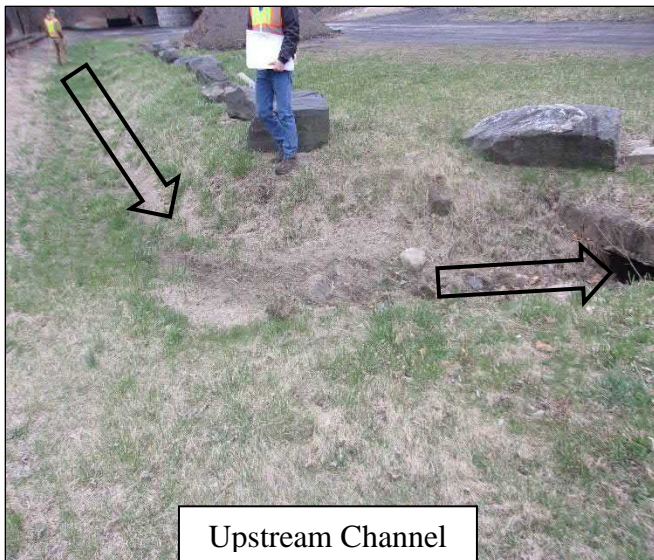
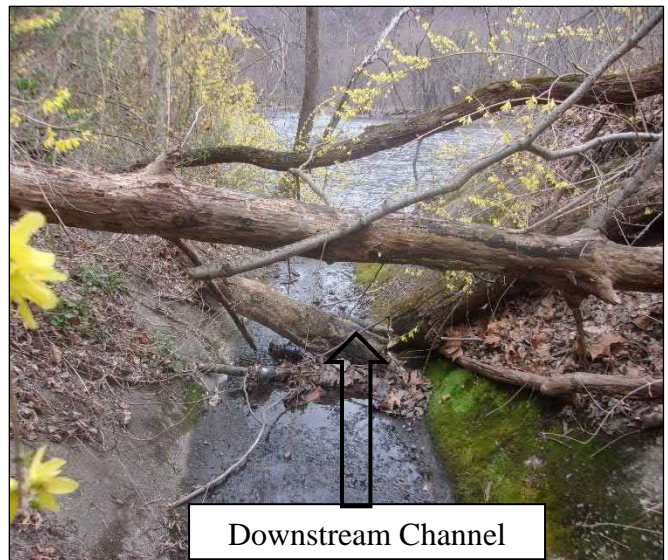
DRAINAGE OBSERVATION		
Condition	Inlet	Outlet
Overgrown		
Crushed		
Eroded		
Sedimentation		
Estimated % Blocked	50	
Deteriorated/Rusted		
Ponding/Incomplete Drainage		
Poor Channel Alignment		
Baseflow Present

Drainage Recommendations:

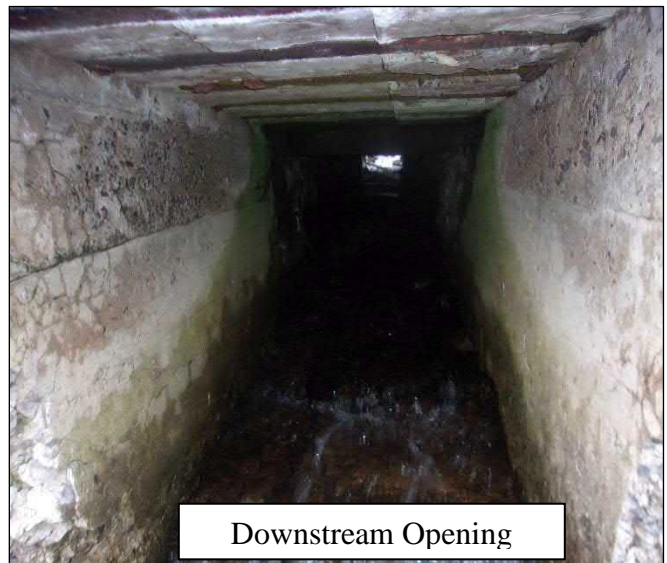
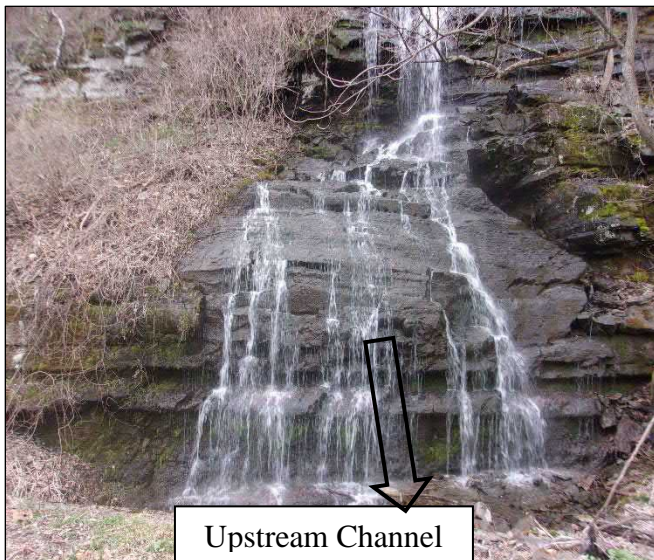
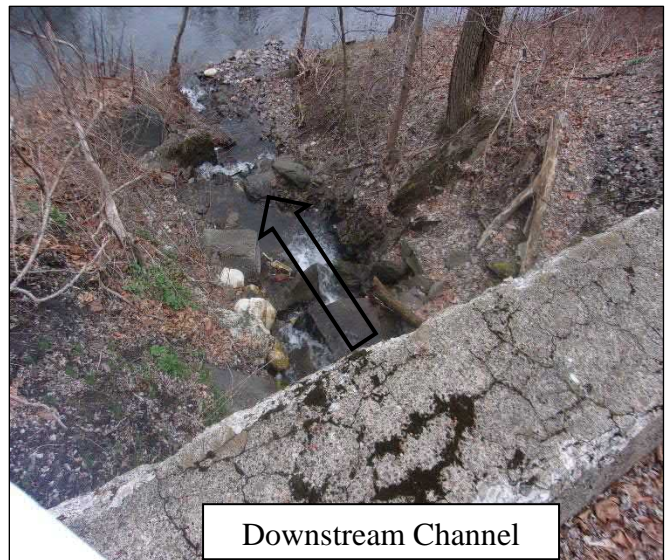
DRAINAGE OBSERVATION		
Condition	Inlet	Outlet
Overgrown		
Crushed		
Eroded		
Sedimentation		
Estimated % Blocked		
Deteriorated/Rusted		
Ponding/Incomplete Drainage		
Poor Channel Alignment	X	
Baseflow Present	X	X

Drainage Recommendations:

- Remove debris and excavate as needed to expose inlets.
- Grade a channel to ensure positive drainage from location of observed ponding to inlets.
- Stabilize entrance with a rock apron.

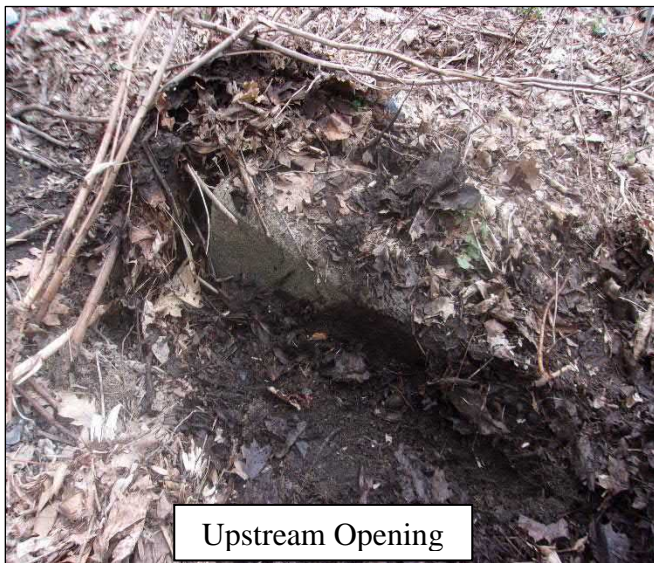
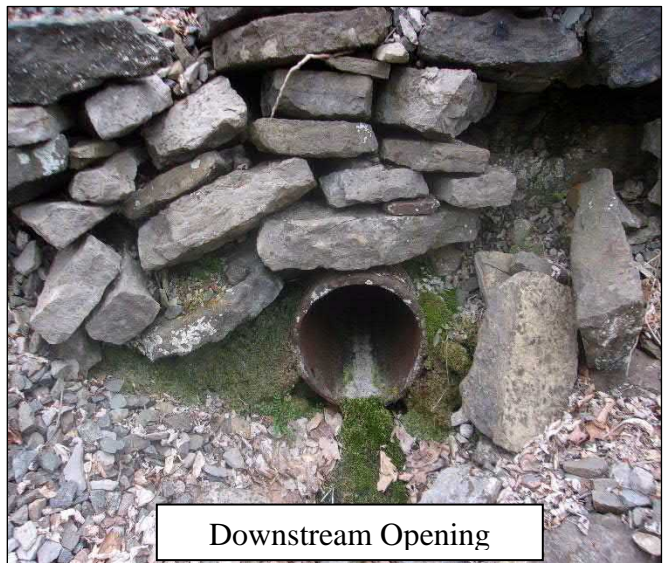
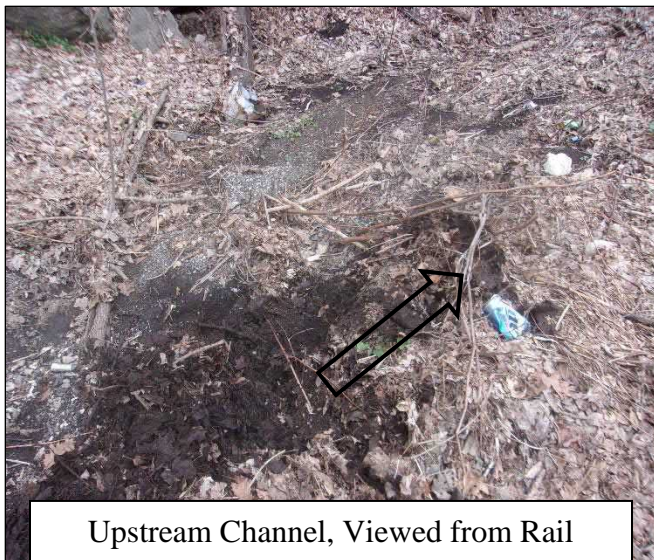
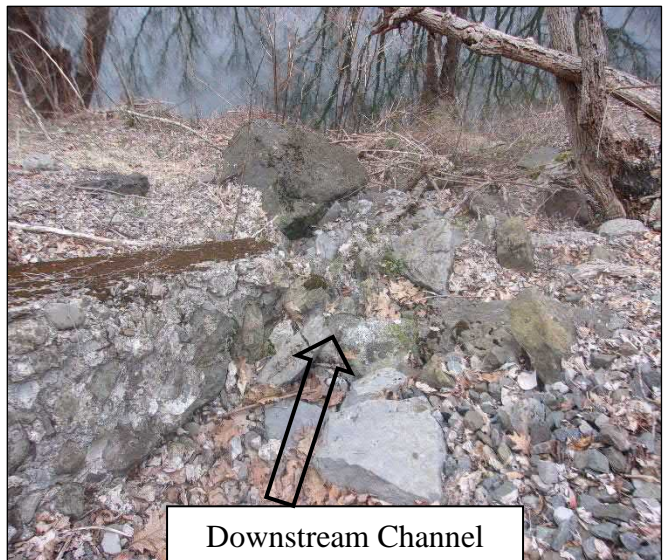
DRAINAGE OBSERVATION		
Condition	Inlet	Outlet
Overgrown		
Crushed		
Eroded		
Sedimentation		
Estimated % Blocked	90	
Deteriorated/Rusted		
Ponding/Incomplete Drainage		
Poor Channel Alignment		
Baseflow Present

Drainage Recommendations:

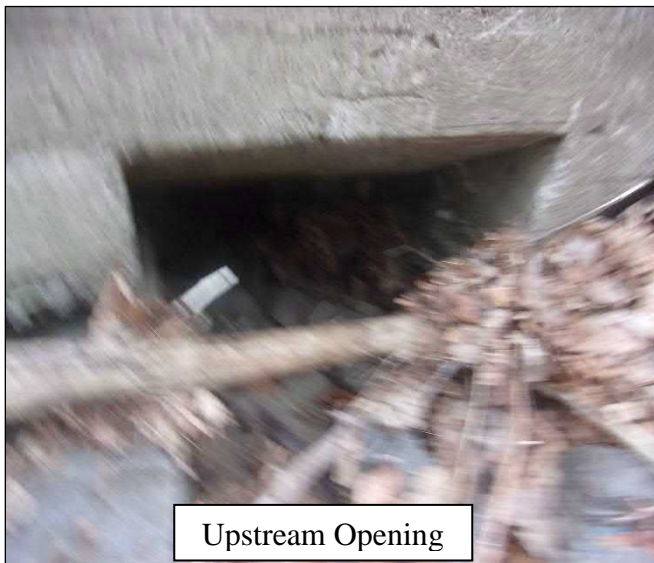
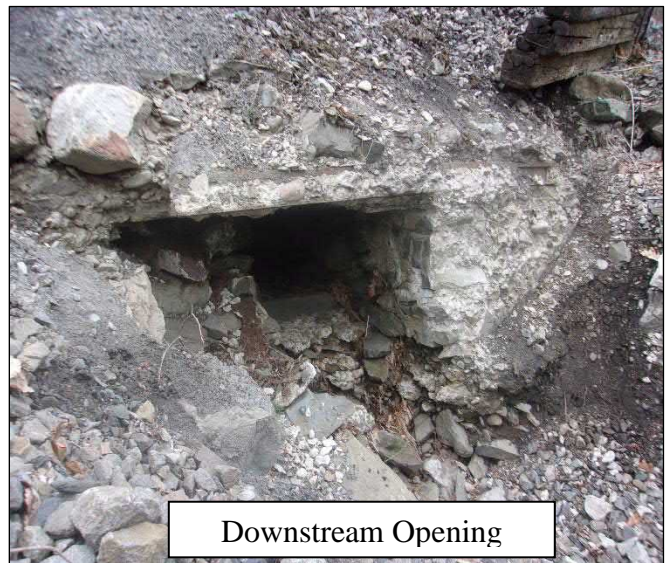
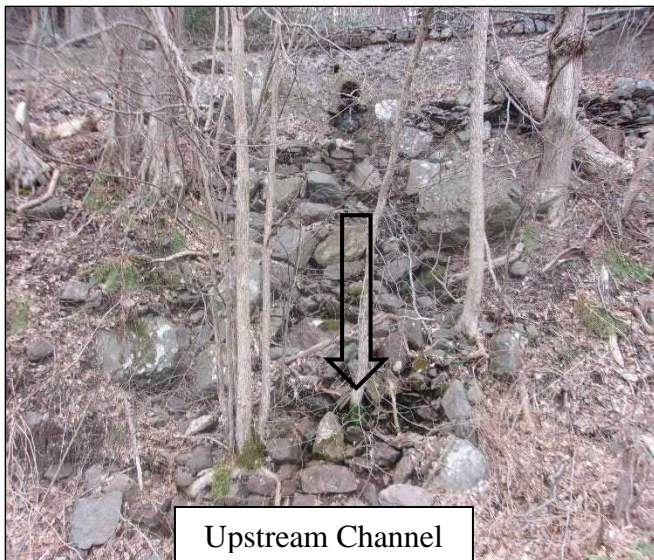
DRAINAGE OBSERVATION		
Condition	Inlet	Outlet
Overgrown		
Crushed		
Eroded		
Sedimentation		
Estimated % Blocked	20	
Deteriorated/Rusted		X
Ponding/Incomplete Drainage		
Poor Channel Alignment		
Baseflow Present

Drainage Recommendations:

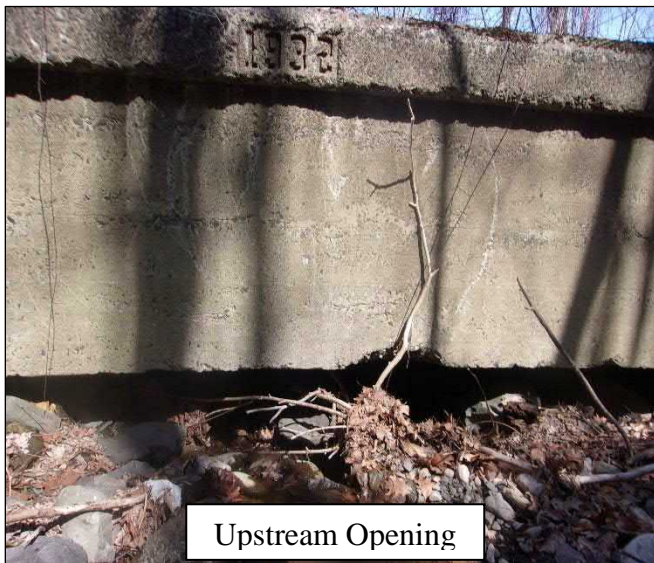
Upstream Opening

DRAINAGE OBSERVATION		
Condition	Inlet	Outlet
Overgrown		
Crushed		
Eroded		
Sedimentation	X	X
Estimated % Blocked	90	
Deteriorated/Rusted		
Ponding/Incomplete Drainage		
Poor Channel Alignment		
Baseflow Present	X	X

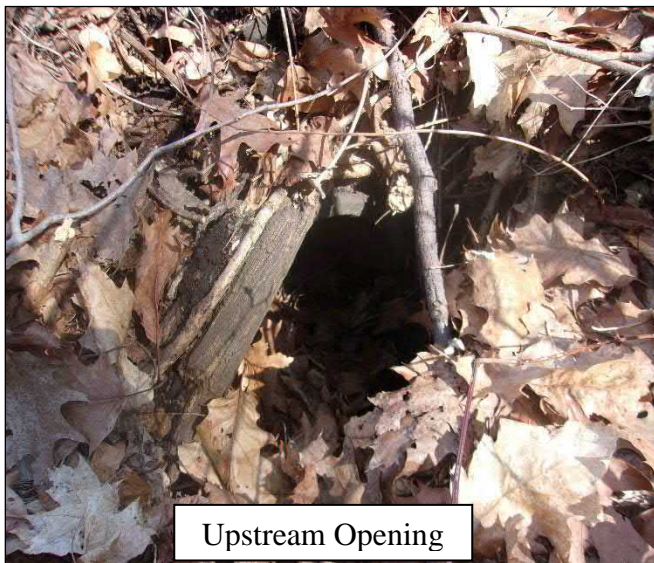
Upstream Opening

DRAINAGE OBSERVATION		
Condition	Inlet	Outlet
Overgrown		
Crushed		
Eroded		
Sedimentation		X
Estimated % Blocked	50	
Deteriorated/Rusted		
Ponding/Incomplete Drainage		
Poor Channel Alignment		
Baseflow Present

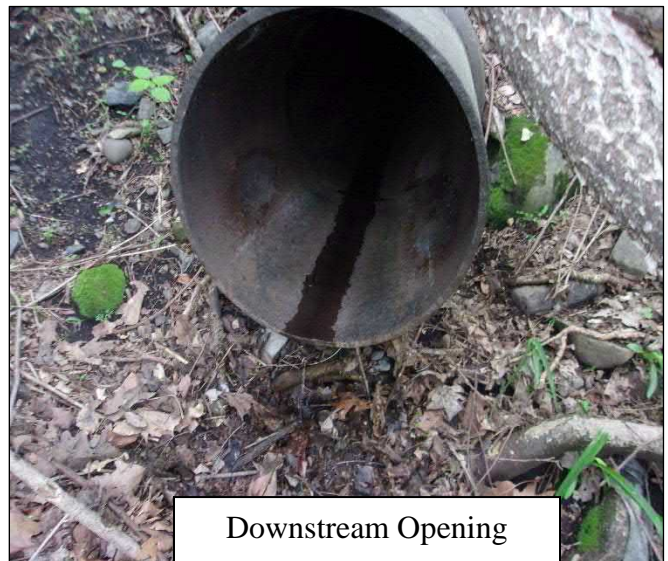
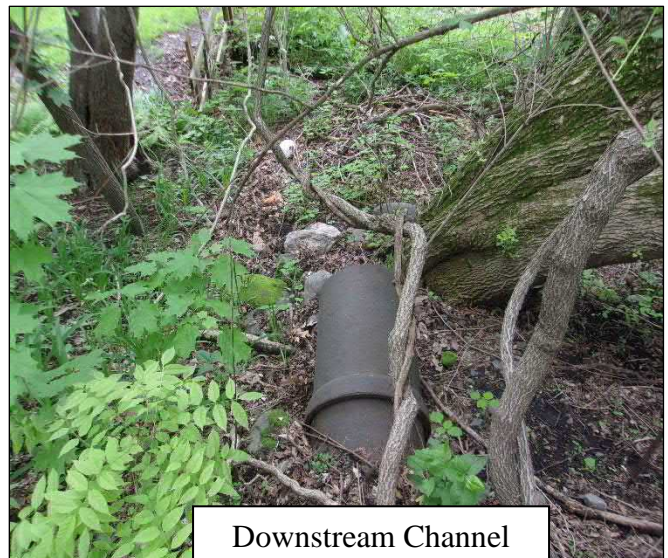
DRAINAGE OBSERVATION		
Condition	Inlet	Outlet
Overgrown		X
Crushed		
Eroded		
Sedimentation		
Estimated % Blocked		
Deteriorated/Rusted		
Ponding/Incomplete Drainage		
Poor Channel Alignment		X
Baseflow Present

Pipe ID: Pipe 30
 Pipe Station: 202+50 (Abandoned Line)
 Pipe Size: 18"
 Pipe Material: Corrugated Metal
 Apron: Yes / No
 Drainage Area: 6.27 acres

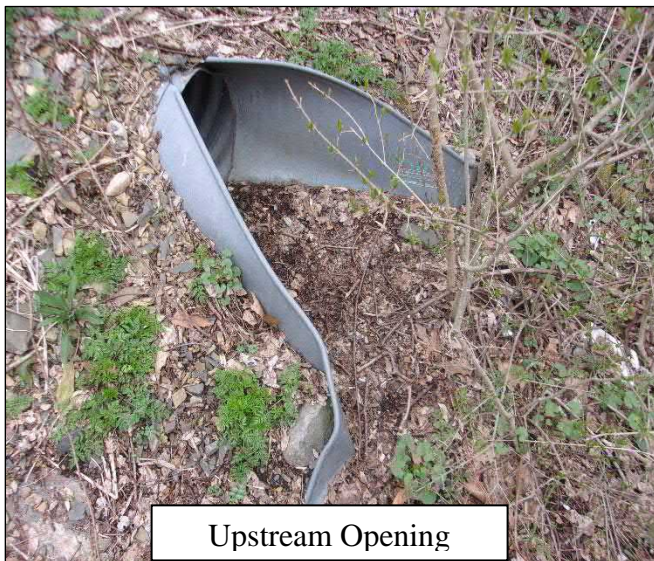
Upstream Opening

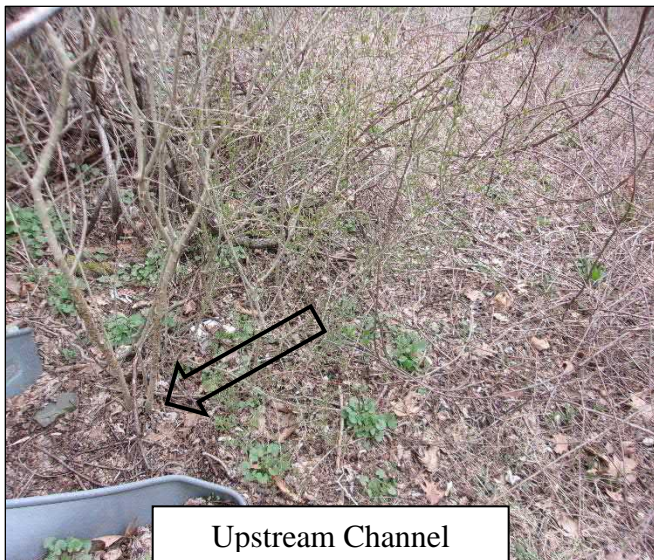
Upstream Channel

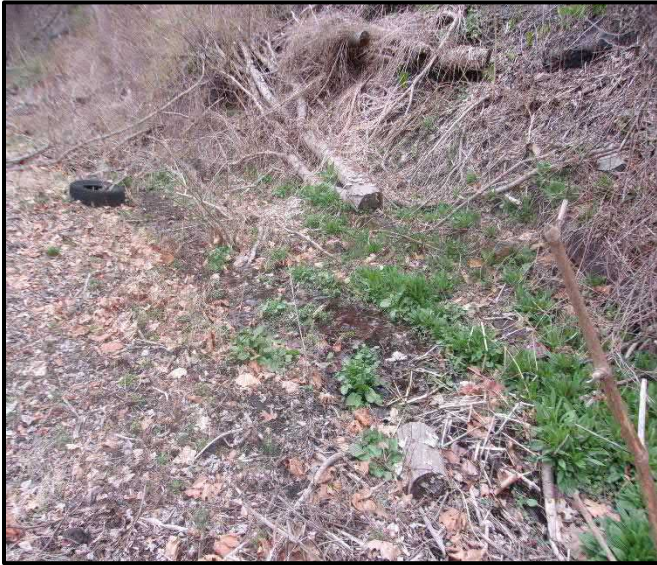
Refer to Appendix A, Existing Drainage Plans, Sheet 5

STA: 52+90 to 53+90

Width: 10 ft

Depth: 0.25 ft

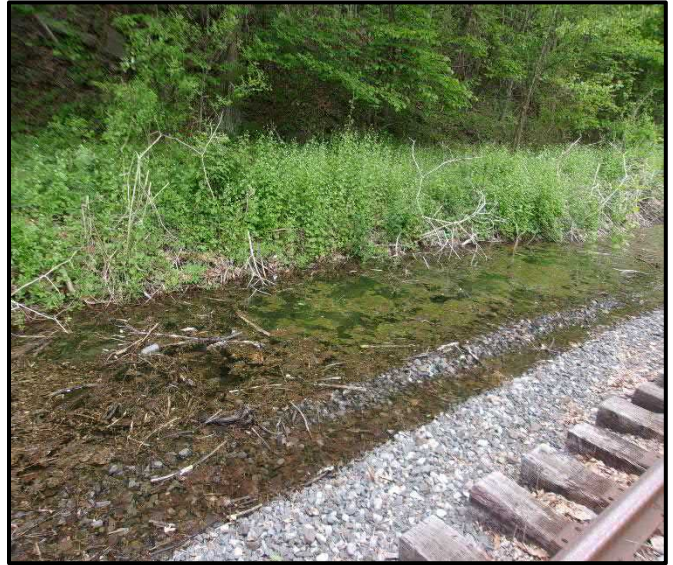
Refer to Appendix A, Existing Drainage Plans, Sheet 13

STA: 147+50 to 149+25

Width: 20 ft

Depth: 0.75 ft

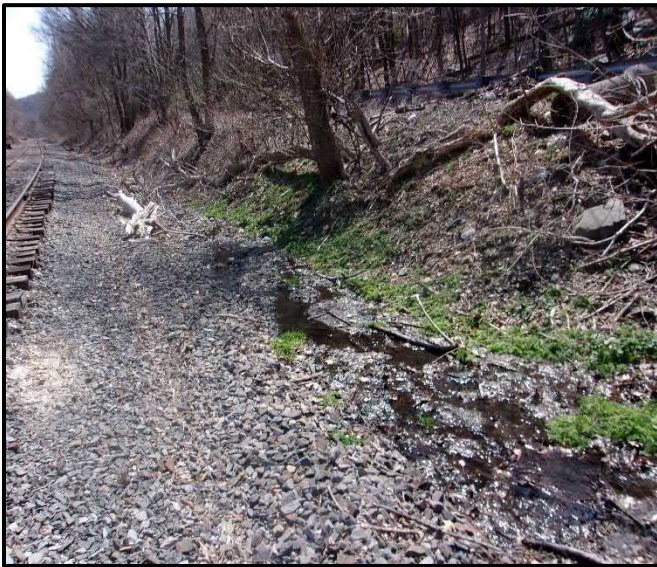
Refer to Appendix A, Existing Drainage Plans, Sheet 13

STA: 145+00 to 146+00

Width: 15 ft

Depth: 0.50 ft

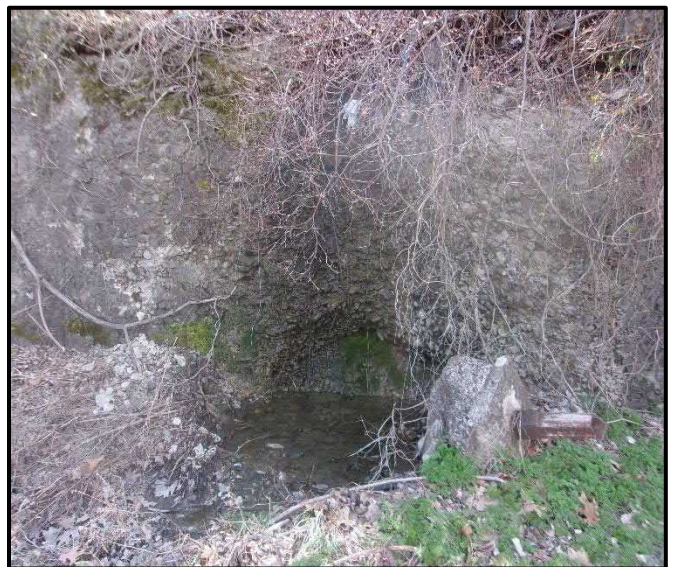
Refer to Appendix A, Existing Drainage Plans, Sheet 16

STA: 192+10 to 192+40

Width: 20 ft

Depth: 0.75 ft

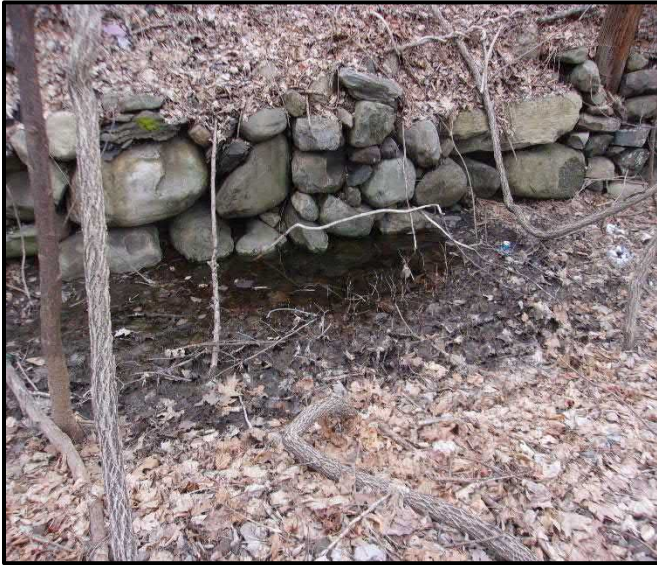
Refer to Appendix A, Existing Drainage Plans, Sheet 18

STA: 229+50 to 229+60

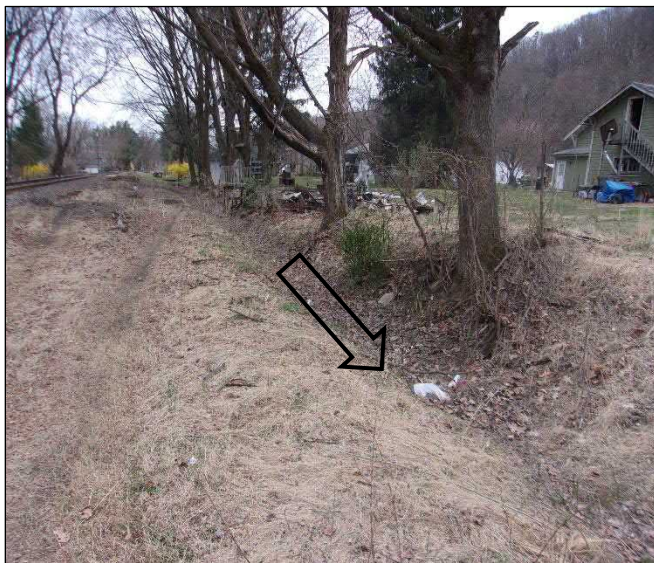
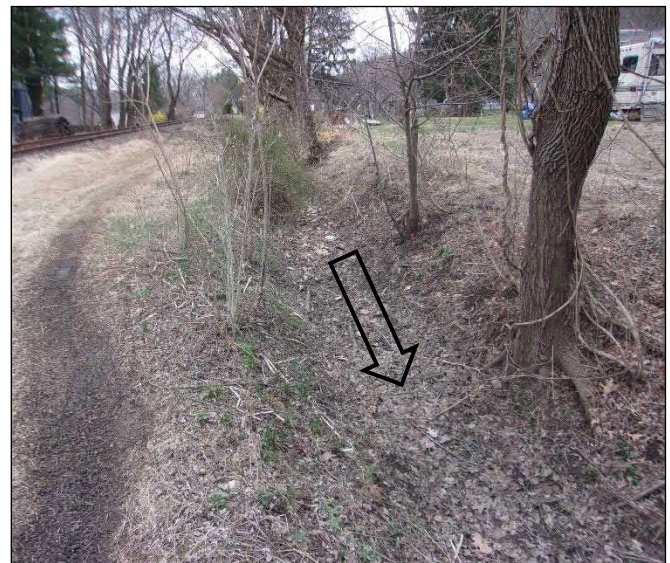
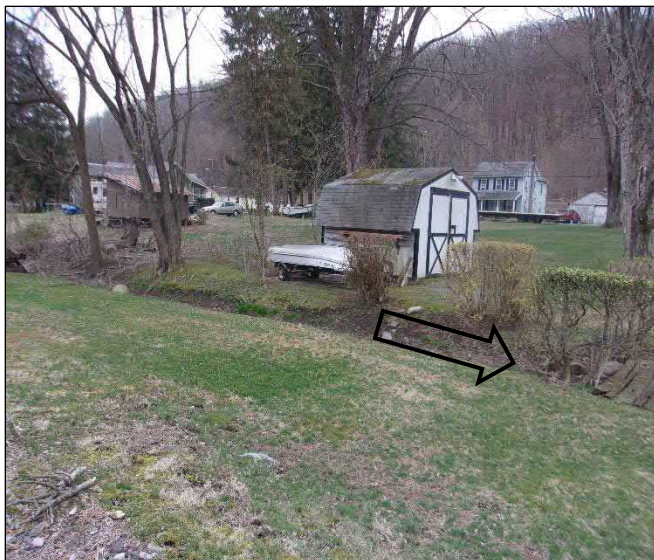
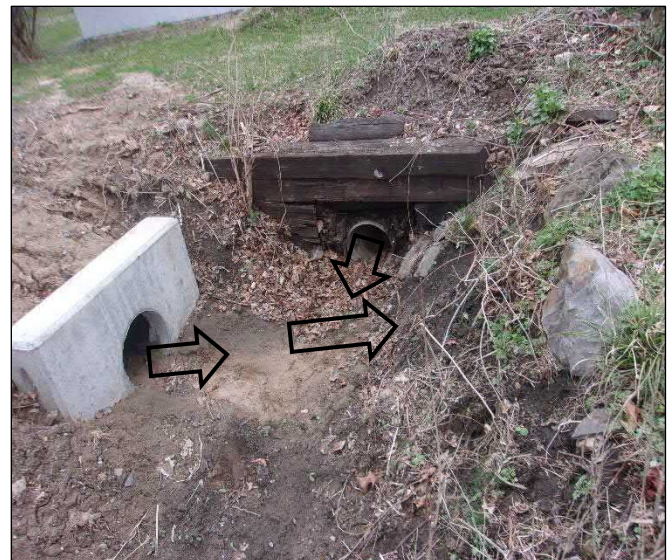
ID: Swale West of Abandoned Rail Line

Depth: 0.5 to 2 ft

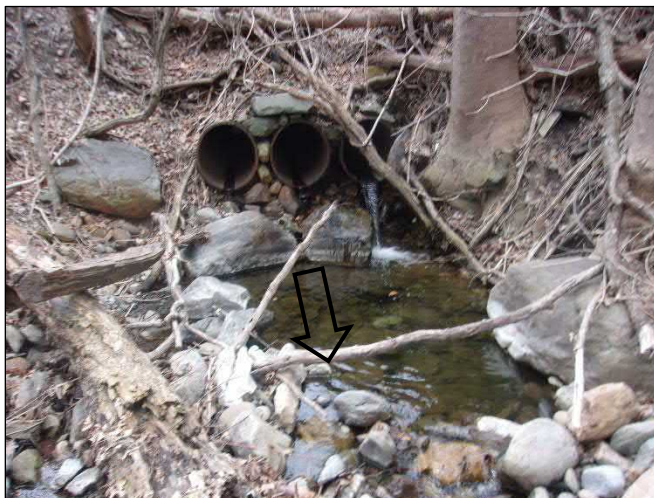
Scour Hole Downstream of Pipes 22, 23, 24

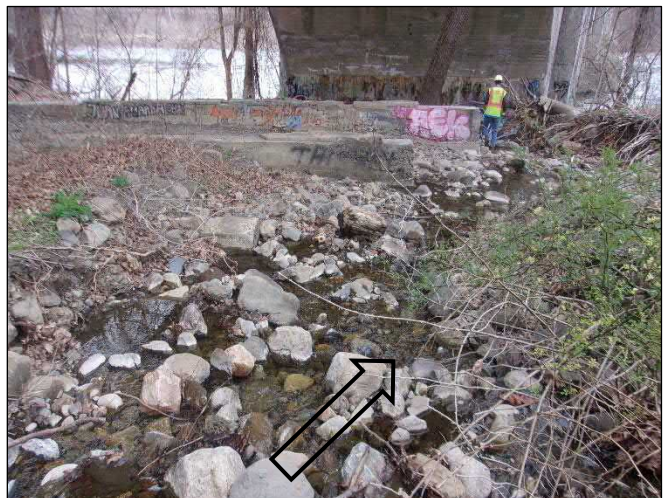
Flow Directed At Delaware Bridge Pier
